NO: SD-SC-001

SAFETY DIRECTIVE -MANDATORY-

MODEL AFFECTED: SPORTCRUISER

SUBJECT: ELEVATOR HORN REINFORCEMENT

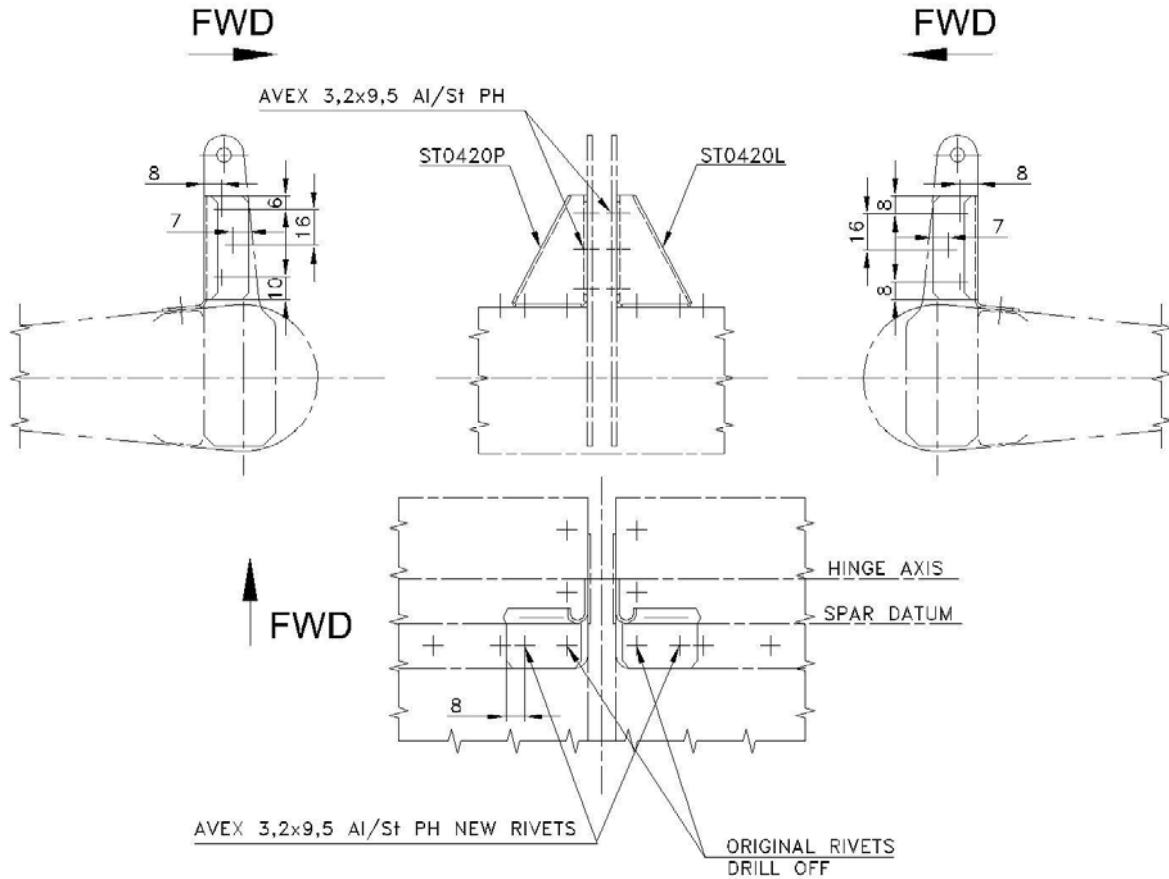
DRAWING 1

Elevator horn must be strengthened to achieve of better rigidity of elevator control system.

1. Remove horizontal stabilizer. Refer to SPORTCRUISER MIP, Chapter 5.3.1.
2. Drill two original rivets off in elevator assembly according to picture 1. Refer to SPORTCRUISER MIP, Chapter 15.
3. Locate and install left and right Reinforcement according to Drawing 1. Use clamps and clecos to fix reinforcement in its correct position. (See picture 1, 2)
