CZECH SPORT AIRCRAFT	<h2 style="margin: 0;">SAFETY ALERT / SAFETY DIRECTIVE</h2>	Czech Sport Aircraft a.s. Na Záhonech 212 686 04 Kunovice Czech Republic office@czechsportaircraft.com
No. SA-SC-007		Rev.: -
Date: 2017-11-29		
Page: 1 of 9		Date: -

MODEL AFFECTED:	SportCruiser
SUBJECT:	Inspection and / or replacement of the valve push-rod-assy. for ROTAX® Engine Type 912 S2 and 912 ULS2.
AIRCRAFT AFFECTED:	<ol style="list-style-type: none"> 1. Aircraft serial numbers C0552, C0555, C0556, C0576, C0577, C0578, C0579, C0580, C0581, C0582, C0583, C0584, C0585, C0586, C0587, C0588, C0591, C0592, C0593, C0594, C0595, C0596, C0597, C0598, C0599, C0600, C0608, C0609, C0610, C0611, C0612, C0613, C0614, C0615 2. All other aircraft the engine of which has been equipped with valve push-rod assy. part no.854861 during the engine repair, maintenance or general overhaul within the period as of 01 May 2016 till 30 November 2017, inclusive. 3. All other aircraft with any of the following engine S/N installed:: <ul style="list-style-type: none"> - from S/N 6 772 119 up to S/N 6 772 185 inclusive - from S/N 9 580 001 up to S/N 9 580 262 inclusive - from S/N 6 785 892 up to S/N 6 786 198 inclusive - f

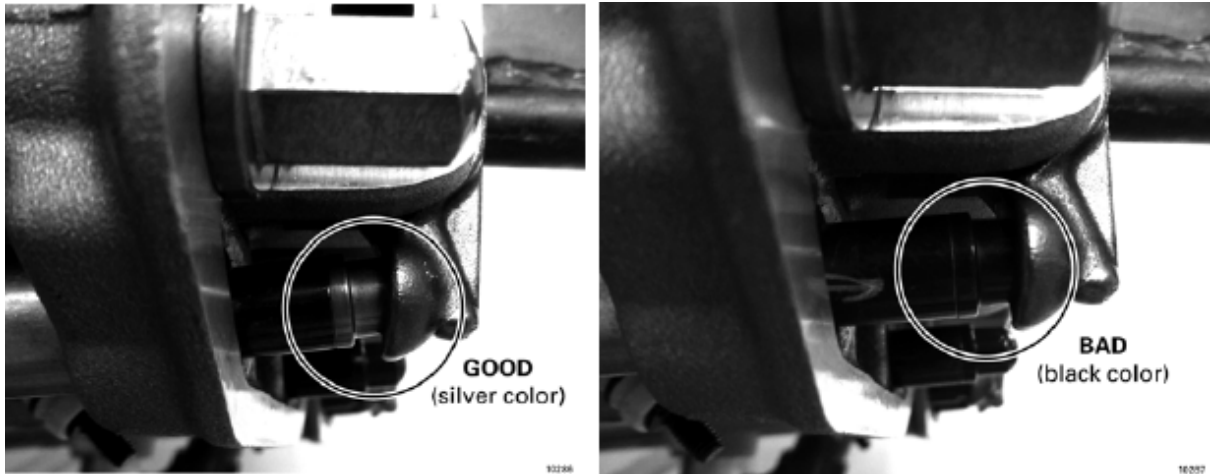
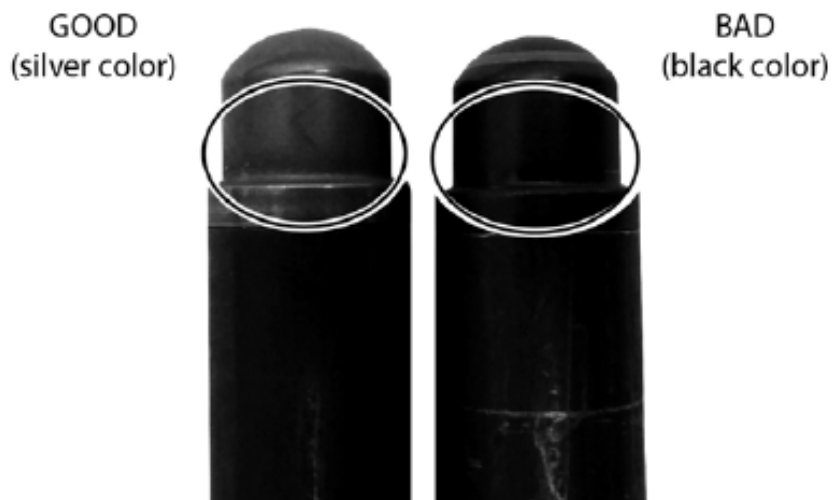
Fig.1 – Visual inspection

This Safety Alert contains instructions for inspection and / or replacement of the valve push-rod-assy., rocker arm left/right for ROTAX® Engine Type 912 (Series). Power loss and engine RPM drop have been reported on Rotax 912 engines in service. It has been determined that, due to a quality control deficiency in the manufacturing process of certain push-rod assemblies, manufactured between May 01, 2016 and October 02, 2017 inclusive, partial wear on the rocker arm ball socket may occur, which may lead to malfunction of the valve train.

Perform visual inspection of all push-rod ball sockets on all cylinder.
Check for color. See Fig.1.

Color	Evaluation
Silver surface	Valve push-rod is OK. No further action required for this valve push-rod.
Black surface	Valve push-rod is NOT OK. See section. 13.6) Replacement of affected parts.

13.6 Replacement of affected parts on affected cylinder positions (only in case visual inspection is NOT passed OK)

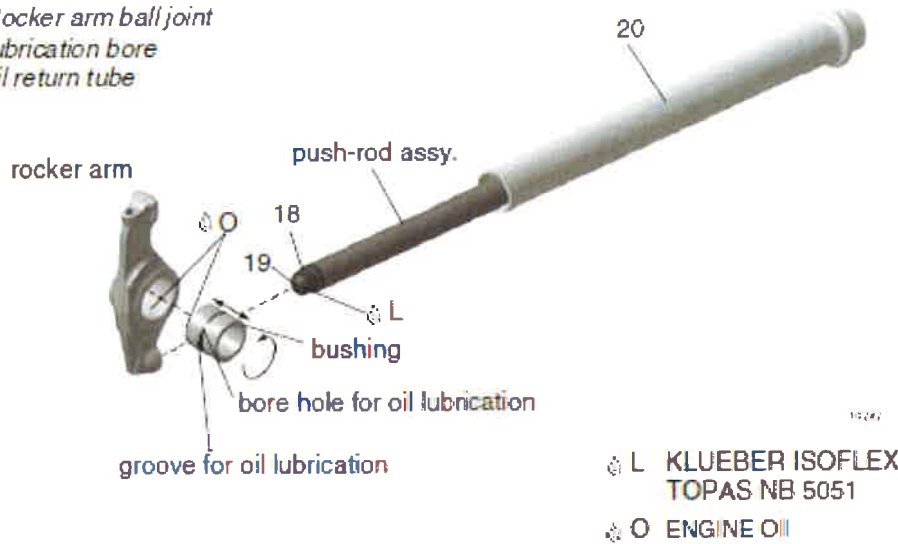
18 Rocker arm ball joint
 19 Lubrication bore
 20 Oil return tube

Step	Procedure
6	This will relieve the pressure from both hydraulic tappets. Now the rocker arm shaft (9) may be easily pulled out. Lift out both rocker arms (10) and (11).
7	Replace only affected parts as per section 11.3). See also Fig. 3 .
8	Apply KLÜBER ISOFLEX TOPAS NB 5051 (16) on both push-rod ball sockets and contact areas of rocker arm and slide push-rod into the oil return tube (20).
9	Check bushing and rocker arm shaft according to latest Maintenance Manual Heavy.
10	Put oil on the rocker arm bushing.
11	Place rocker arm left (10) and rocker arm right (11) in cylinder head, apply KLÜBER ISOFLEX TOPAS NB 5051 (16) on rocker arm shaft (9) and insert it into its bearing support.
12	Loosen valve spring loading jig and support plate.
13	When removing the valve spring loading jig , make sure the adapter rings (15) do not jam on the valve spring retainer.
14	NOTE: Only when you have an Criterion B) Spare parts affected engine and only if engine is equipped with collar cap nuts M8 wrench size 13: Mount collar cap nut (6) according to latest Maintenance Manual Heavy or SI-912-025/SI-914-026/SI-912 i-010.
