CZECH SPORT AIRCRAFT	<h2 style="margin: 0;">SAFETY ALERT / SAFETY DIRECTIVE</h2>	Czech Sport Aircraft a.s. Na Záhonech 212, 686 04 Kunovice Czech Republic office@czechsportaircraft.com
No. SA-SC-009		Rev.: -
Date: 2018-11-08		
Page: 1 of 6		Date: -

MODEL AFFECTED:	SportCruiser / PiperSport (except the aircraft under EASA Permanent Flight Conditions).
SUBJECT:	Change of maximum operating temperature limit determination related to the change from the original Cylinder Head Temperature measurement method to the new Coolant Temperature measurement method for aircraft equipped with Rotax 912 ULS2 engines with a new cylinder head design.
AIRCRAFT AFFECTED:	All SportCruiser / PiperSport airplanes from section "MODEL AFFECTED" equipped with Rotax 912 ULS2 engine S/N starting from 6 770 937 inclusive, or with Rotax 912 engines with type designation followed by suffix-01, or with all other Rotax 912 engines equipped with the new cylinder heads design bearing P/N 413185 at cylinder head measuring position 2/3.
COMPLIANCE:	Execution of this Safety Alert is mandatory and must be performed immediately. Instructions contained herein, if not followed, may lead to unsafe conditions, resulting in a

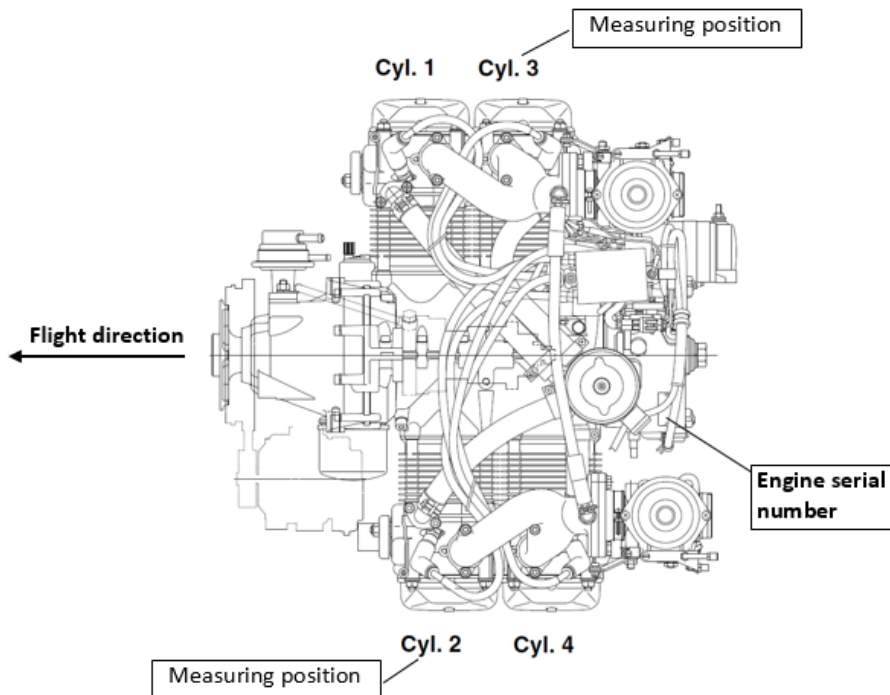
Figure 1: Location of the engine serial number and cylinder head positions

- a) **The engine serial number** is located on the top of the crankcase, magneto side. Basic scheme of the Rotax 912 engine with location of the engine serial number and cylinder heads positions, see Figure 1.

1. Move the aircraft to a suitable place to perform the work. Remove the upper and bottom engine cowlings.
2. Check the engine serial number to find out if the aircraft is affected by this Service Alert, see Figure 1 above.

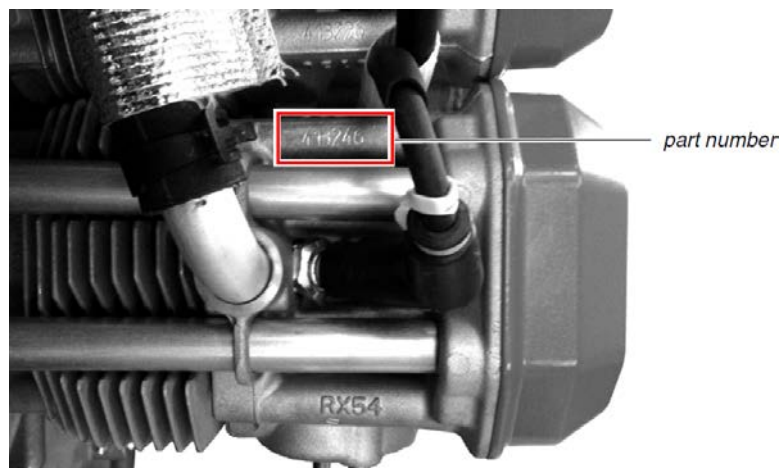
Figure 2 - Part number location of cylinder head

- b) **The temperature sensors** are located on cylinder 2 and 3. For checking whether the engine is equipped with the new cylinder head design (P/N 413185 for 2/3 cylinder head) or not, read the Part number of the 2/3 cylinder heads, see Figure 2.

3. Check the part numbers of the cylinder heads at the measuring positions 2/3, see Figure 1 and Figure 2 above.
4. If the **cylinder heads with the new design are not installed**, enter the aircraft log book and insert the following text: *“The SA-SC-009 applicability has been checked with the result not applicable. Cylinder heads with new design are not installed”*.

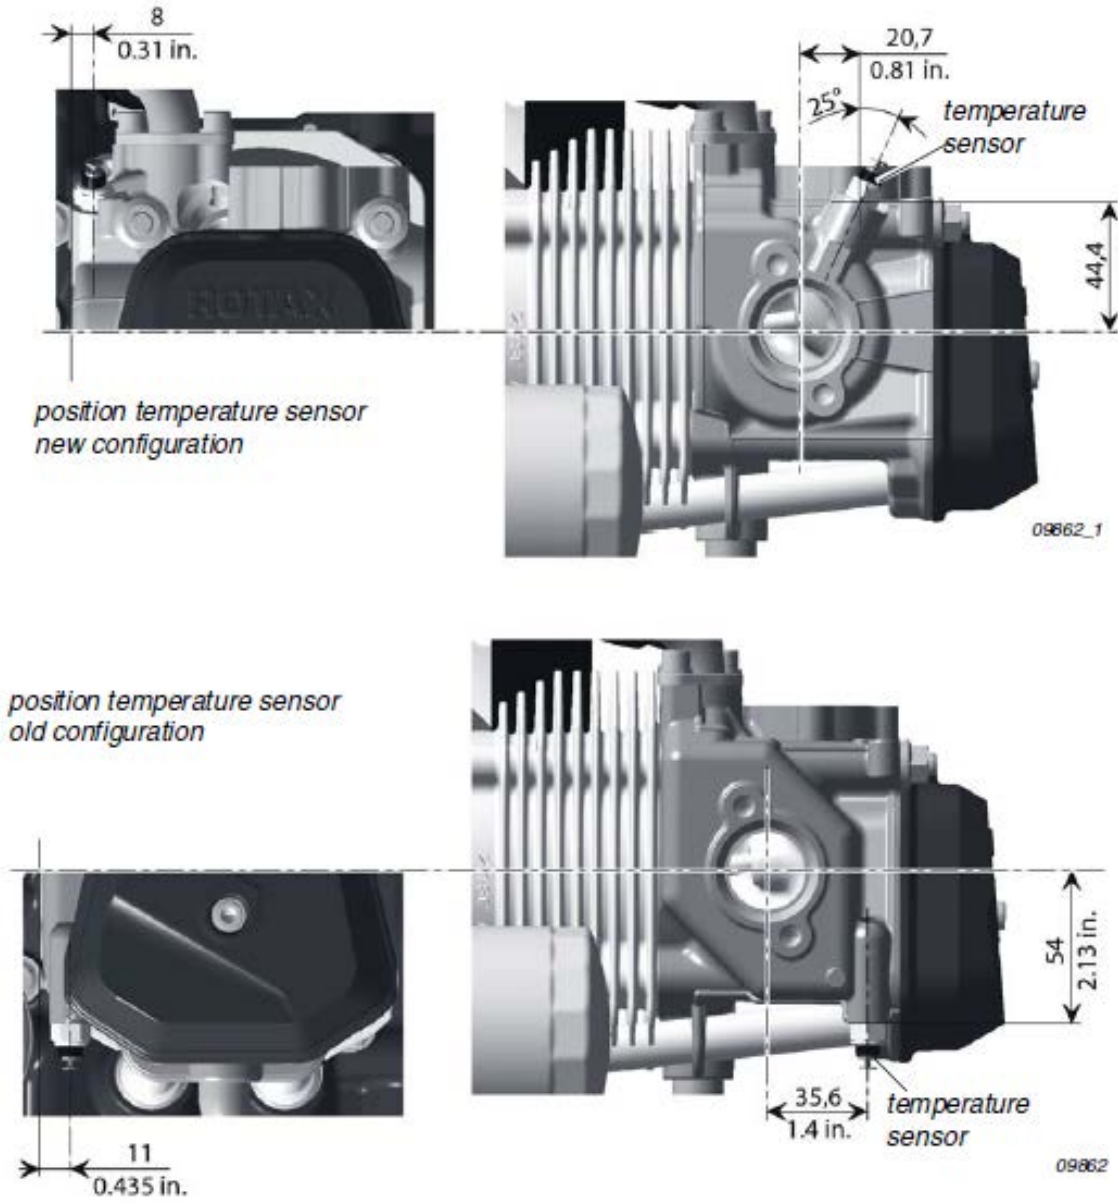
*Figure 3
Difference between the old and new cylinder head design and temperature sensor position*

c) For recognizing the **difference between the old and new cylinder head design and the temperature sensor position**, see Figure 3.
