Czech Sport Aircraft a.s.	SERVICE BULLETIN	Czech Sport Aircraft a.s. Na Záhonech 212, 686 04 Kunovice Czech Republic office@czechsportaircraft.com
No. SB-CR-031		Rev.: -
Date: 2015-08-10		
Page: 1 of 2		Date: -

MODEL AFFECTED:	SportCruiser , PS-28 Cruiser
SUBJECT:	Inspection/replacement of the Semperit FUB 386 fuel hoses
AIRCRAFT AFFECTED:	SportCruiser, serial numbers: C0524, C0525, C0526, C0527,C0528 PS-28 Cruiser, serial numbers : C0504, C0519,C0521
COMPLIANCE:	From the date of issue of this Service Bulletin

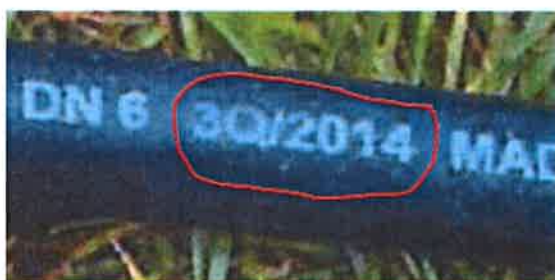
The CSA had been informed of a problem with a recently manufactured batch of the Semperit Fuel Hose FUB 386 3Q/2014. The affected batch is clearly printed with 3Q/2014 (manufactured in 3rd quarter 2014). No reported faults with earlier batches of the hose are known.

Hose with Quarter and the year print

5. Check printing of all fuel hoses installed on the aircraft.
6. If no fuel hoses with the print 3Q/2014, no hoses with an illegible or with missing print are found then connect the fuel hose back to the fitting - pull on the protective pyrojacket back, fit the hoses ends with the Thermofit CGPT hose and tighten with hose clamps. Then continue with the point No.8.

7. If any of the fuel hoses with 3Q/2014, illegible or missing print are found then drain all fuel from the system and replace the faulty fuel hoses. Fit them back with the protective pyrojackets, Thermofit CGPT hoses and hose clamps. Tighten the hose clamps.

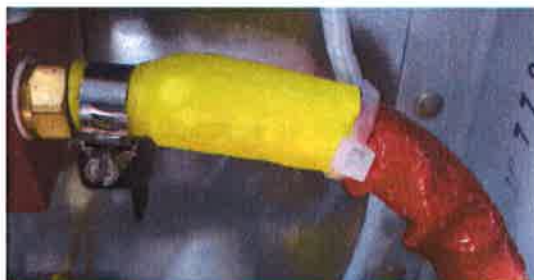
Fuel hose with Pyrojacket, hose clamp and Thermofit CGPT hose

1. Move the airplane to a suitable place to perform the work
2. Remove engine cowlings, disconnect positive battery terminal (see the Maintenance Manual).
3. To get a sufficient access to the areas with fuel hoses, open the relevant inspection holes (follow the Maintenance Manual).
4. The hoses are marked with print at every app. 30 cm of their length. A part of the print is a quarter and a year of the batch, see the picture bellow. The fuel hoses in engine area are covered by protective pyrojackets and the hoses ends are fitted with Thermofit CGPT hoses (yellow) for easy attachment to the sockets, see the picture bellow. Before the print check it is necessary to disconnect the hose from the fitting, i.e. untighten the hose clamp, cut up the Termofit CGPT hose (yellow) and draw down the pyrojacket.
