Czech Sport Aircraft a.s.	<b>SERVICE BULLETIN</b>	Czech Sport Aircraft a.s. Na Záhonech 212, 686 04 Kunovice Czech Republic office@czechsportaircraft.com
No. SB-CR-032		Rev.: -
Date: 2015-10-23		
Page: 1 of 13		Date: -

<b>MODEL AFFECTED:</b>	PS-28 Cruiser / SportCruiser / PiperSport
<b>SUBJECT:</b>	Reinforcement of the nose wheel leg attachment to the firewall
<b>AIRCRAFT AFFECTED:</b>	All PS-28 Cruiser, SportCruiser, PiperSport aircraft equipped with or being in process of installation of the new NLG leg – dwg. SG0300N.
<b>COMPLIANCE:</b>	Apply this Service Bulletin not later than at the next scheduled inspection after 50 flight hours (see the CR-MM-1-0-00, Rev.13, Chapter 2, point 2.5.1.e) or promptly after issue of this Bulletin in case that local cracks and/or deformation of vertical brackets on the nose landing gear leg attachment to the firewall are discovered, or upon installation of a new NLG leg – dwg. SG0300N.

This Service Bulletin contains instructions for installation of parts for reinforcement of the nose landing gear leg attachment to the firewall.

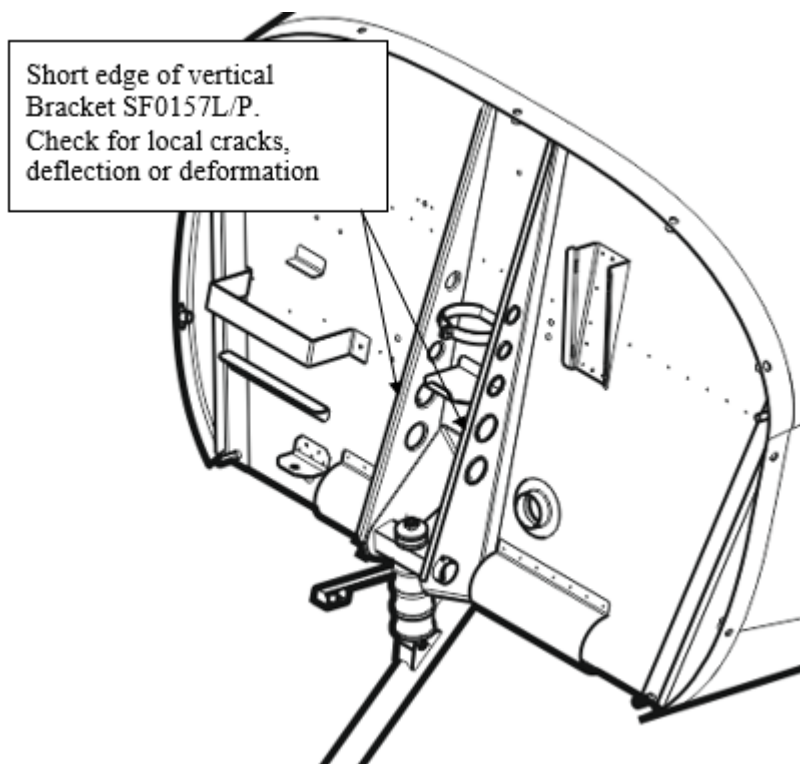
Scheme No.1 – Parts on the Firewall to be checked for possible local cracks, deflection or deformation

Minor local cracks and deformations of the SF0157L/P vertical brackets short edge in the nose landing gear leg attachment to the firewall were discovered on some PS-28 Cruiser aircraft. To avoid a possible occurrence of this situation a set of parts to increase the carrying capacity of the SF0157L/P vertical brackets by means of SF0602L/P stiffener, SF0604/N bulkhead and SF0601L/P "U" stiffener has been developed.

6. Now the landing gear attachment area on the firewall should be easily accessible.
7. Check thoroughly again the nose wheel leg attachment area for cracks and deformation. Stop enlarging of cracks by drilling a hole with the drill bit of dia. 3,2 mm at the utmost end of the crack, for details see the CR-MM-1-0-00 , Chapter 15, point 15.1 and point 15.4.5.1. Straighten out all bent or deformed parts.
