Czech Sport Aircraft a.s.	SERVICE BULLETIN	Czech Sport Aircraft a.s. Na Záhonech 212, 686 04 Kunovice Czech Republic office@czechsportaircraft.com
No. SB-CR-033		Rev.: -
Date: 2016-03-18		
Page: 1 of 10		Date: -

MODEL AFFECTED:	PS-28 Cruiser SportCruiser / PiperSport - under EASA PtF operation only
SUBJECT:	Change from Cylinder Head Temperature to Coolant Temperature measurement method for aircraft equipped with Rotax 912 ULS and 912 S2 series engine with a new cylinder head design.
AIRCRAFT AFFECTED:	PS-28 Cruiser up to S/N C0556 including SportCruiser – all S/N PiperSport – all S/N
COMPLIANCE:	As per EASA AD 2015-0240 (for Rotax engines)

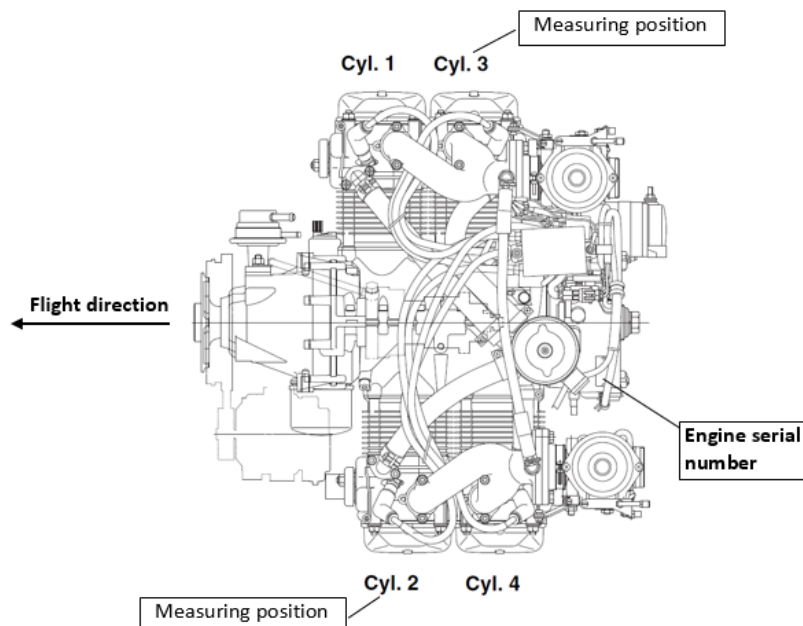
Figure 1 Location of the engine serial number and cylinder head positions

- a) **The engine serial number** is located on the top of the crankcase, magneto side.
Basic scheme of the Rotax 912 engine with location of engine serial number and cylinder heads positions, see Figure 1.

1. Move the aircraft to a suitable place to perform the work. Remove the bottom and upper engine cowlings.
2. Check the engine serial number S/N to find out if the aircraft is affected by this SB, see Figure 1 above.

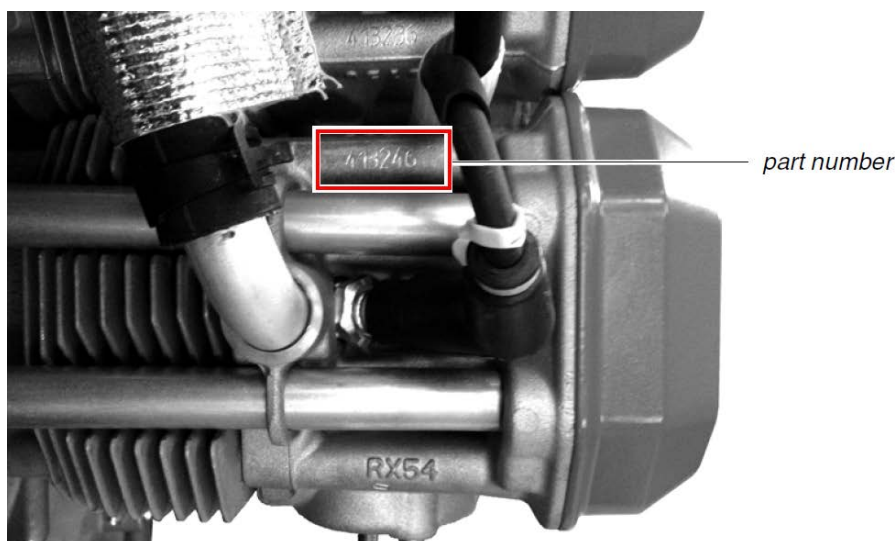
Figure 2 - Part number location of cylinder head

- b) **The temperature sensors** are located on cylinder 2 and 3. To recognize whether the engine is equipped with the new cylinder head design (P/N 413185 for 2/3 cylinder head) or not, read the Part number of the 2/3 cylinder heads, see Figure 2.

3. Check the part numbers of the cylinder heads at the measuring positions 2/3, see Figure 1 and Figure 2 above.
Send a written report to Czech Sport Aircraft a.s. about the check result (Date, Aircraft S/N, New cylinder heads design was found/not found.)

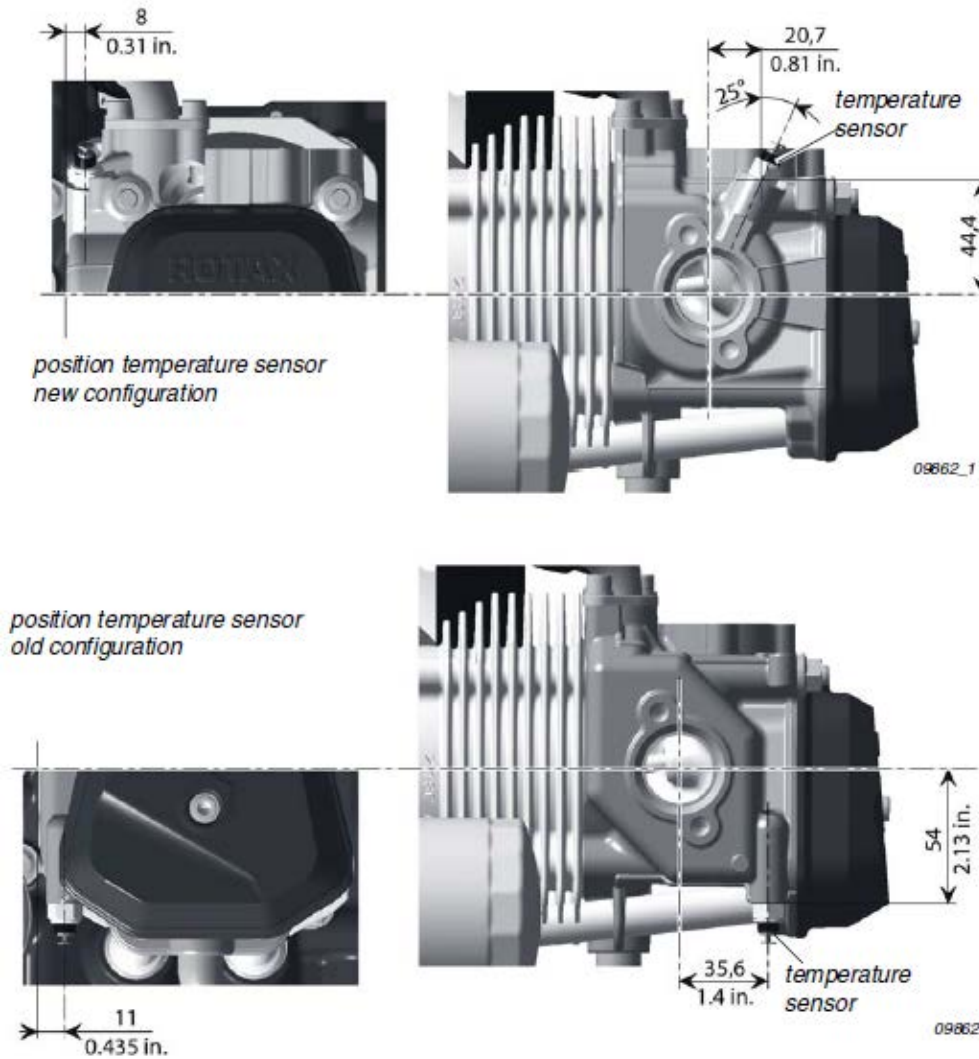
Figure 3 - Difference between old and new cylinder head design and temperature sensor position

With the change to a new cylinder heads design (P/N 413185 at cylinder head position 2/3) no longer the Cylinder Head Temperature is measured, but the Coolant Temperature.

The measuring position of the temperature sensor has changed. With this new installation position of the temperature sensor, a loss of coolant can be recognized easily. The change to the new cylinder heads does not affect the cooling capacity.

- c) To recognize the **difference between the old and new cylinder head design and the temperature sensor position**, see Figure 3.

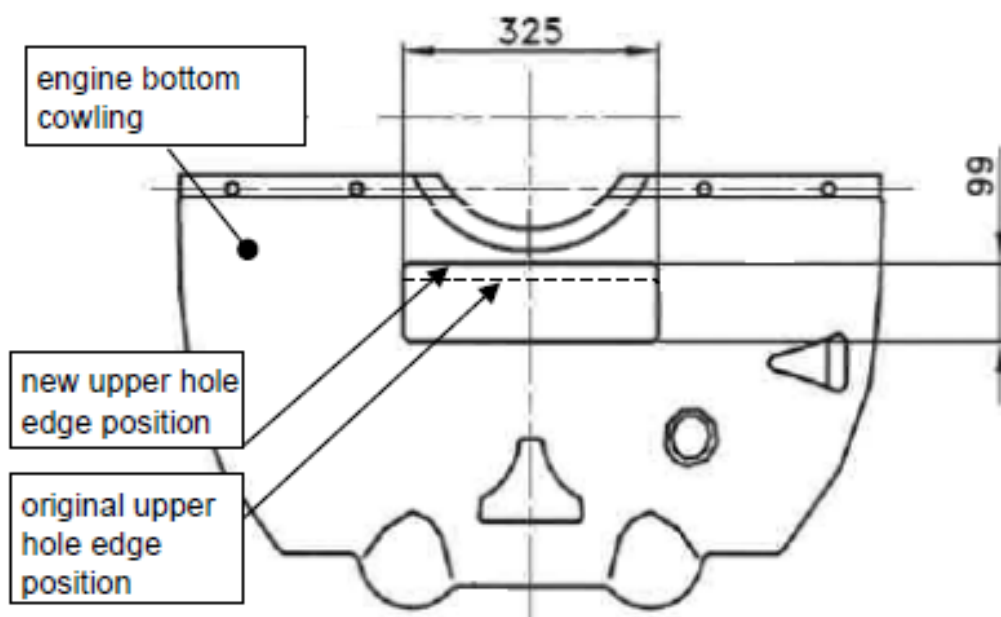
Figure 5 - Extension of the air cooler inlet hole in the engine bottom cowling

Due to these changes the Coolant Temperature (CT) instead of the Cylinder Head Temperature (CHT) in the aluminium is displayed. For that reason it is necessary to check/correct the Coolant Temperature limit (120°C) displayed on the instrument panel, check/correct its naming (CT instead of CHT). To improve the engine cooling characteristics, an extension of the air cooler inlet hole in the engine bottom cowling must be applied.

10. Extension of the air cooler inlet hole in the original engine bottom cowling.

- 10.1. Use the engine bottom cowling, measure out and mark new hole top edge acc. to the Figure 5 below. The new top edge is moved upwards.
- 10.2. Cut off the top rim accordingly to the marking and clean the hole.
- 10.3. Fit in place and adjust the cut off top rim and laminate it back in the extended cowling inlet hole.
- 10.4. Use an additional fiberglass and apply for laminating of side parts of the cowling hole.
- 10.5. Carry out sanding for good adhesion of the repair coats.
- 10.6. Apply a sufficient primer and top coat to restore the original colour design of the surface.
