CZECH SPORT AIRCRAFT	<h1>SERVICE BULLETIN</h1>	Czech Sport Aircraft a.s. Na Záhonech 212, 686 04 Kunovice Czech Republic office@czechsportaircraft.com
No. SB-CR-036		Rev.: 1
Date: 2017-08-29		
Page: 1 of 7		Date: 2017-11-08

<b>MODEL AFFECTED:</b>	PS-28 Cruiser SportCruiser / PiperSport – under EASA PtF operation only
<b>SUBJECT:</b>	Inspection of rivet holes on the firewall
<b>AIRCRAFT AFFECTED:</b>	All PS-28 Cruiser airplanes and SportCruiser / PiperSport operating under EASA PtF conditions
<b>COMPLIANCE:</b>	Apply this Service Bulletin not later than at the next scheduled inspection after 50 flight hours.

This Service Bulletin contains instructions for inspection and eventual repair of rivet holes on the firewall.

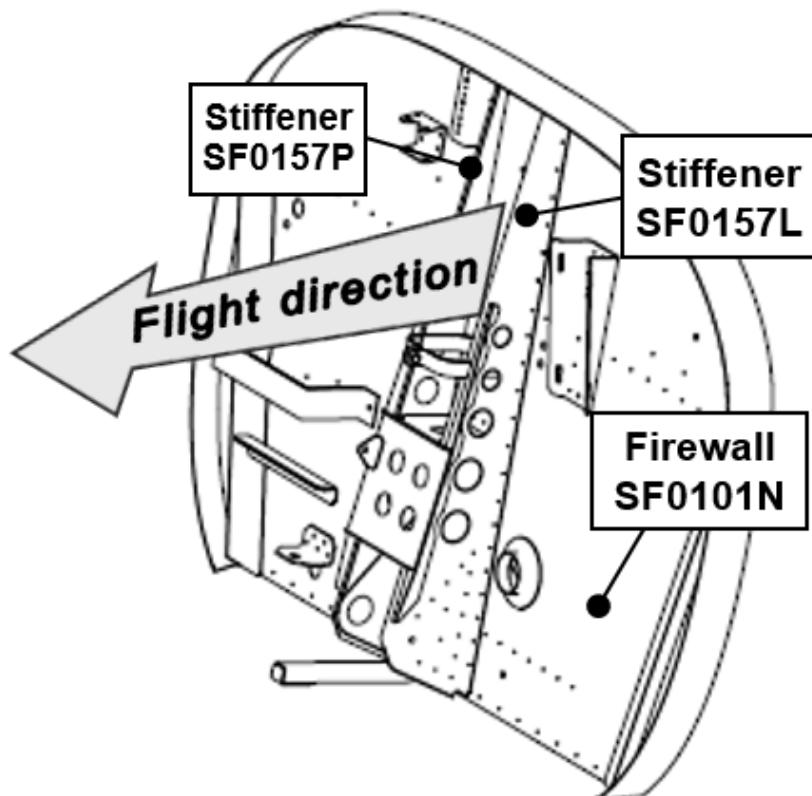
Figure 1 - View of the Firewall – Front view

As some cases of incorrect distribution of rivet holes on the firewall were discovered, it is necessary to inspect that the assembly of the stiffeners P/N SF0157L/P and the firewall P/N SF0101N is riveted correctly. The inspection consists of the check of the uppermost rivet row - see the illustrative figures below (Figure 1, Figure 2, Figure 3). The inspection has to be performed from both sides of the firewall. To get access from the cockpit area, the cover (9) of the rescue parachute box must be removed - see Figure 4 below.

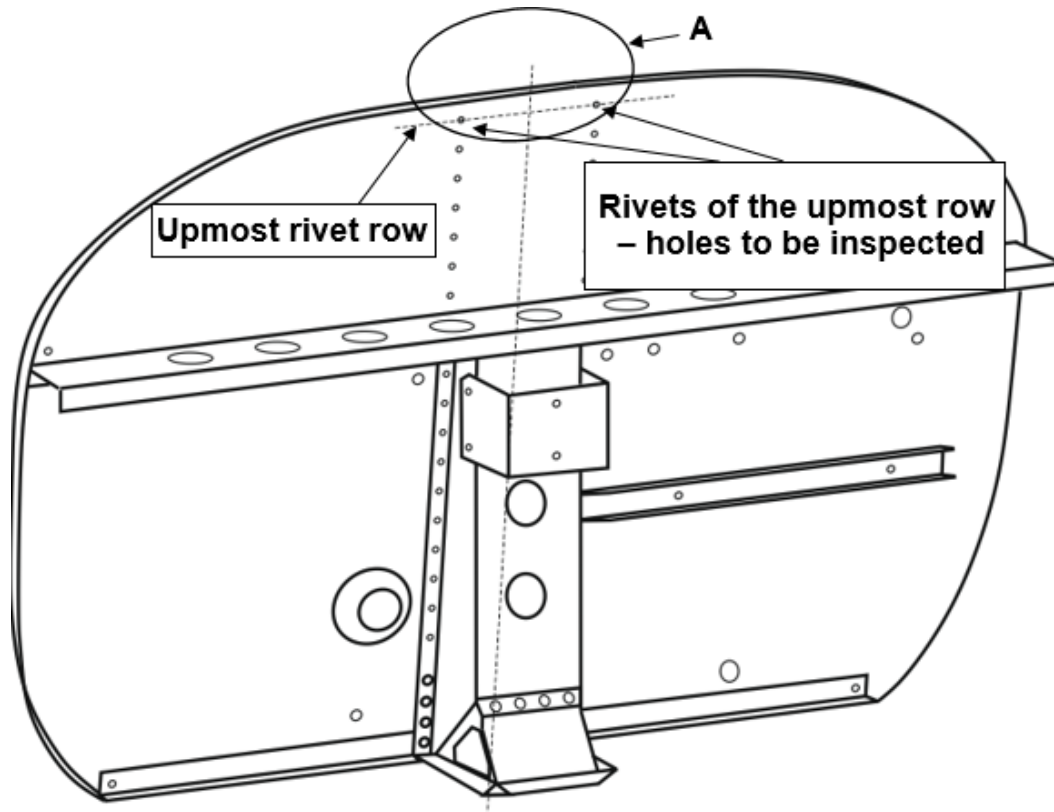
Figure 2 - View of the Firewall – Back view

4. On the firewall, check thoroughly the uppermost row rivets fastening the stiffeners SF0157L/P to the firewall, see the illustrative figures above (Figure 1, Figure 2, Figure 3). The inspection has to be performed from both sides of the firewall.
5. If no ovality or cracks in the firewall near to the inspected area are found, then the rivet joints are to be considered as correct and only the steps 17,19, 20 and 21 of this bulletin are necessary to be performed in such a case.

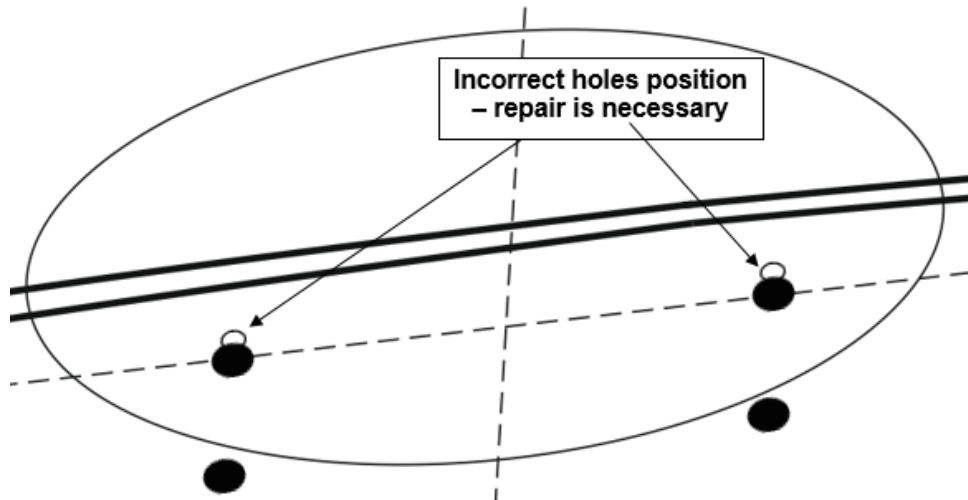
Figure 3 - Detail A

6. If ovality of the rivet holes (the rivet hole edge is visible) or some cracks in the firewall near to the inspected area are found, those rivet joints are considered to be faulty / incorrect and repair in accordance with this bulletin is necessary. Continue with the next step 7 in such a case.
7. Disconnect the positive battery terminal
8. Dismount the left instrument panel with instruments (see Figure 5), put it on a clean soft pad. Do not remove and do not disconnect the instruments.

12. Bore the incorrect rivet holes with drill bit of dia.5 mm, cracks with drill bit of dia.3,2 mm (1/8 in) - see step no. 6 and Figure 3.
13. Touch the reinforcement part to the firewall from the cockpit side, fit the part in accordance with Figure 9, drill the rivet holes and rivet the reinforcement part with the firewall, stiffeners SF0157L/P and the relays holder.
