CZECH SPORT AIRCRAFT	<h1>SERVICE BULLETIN</h1>	Czech Sport Aircraft a.s. Na Záhonech 212, 686 04 Kunovice Czech Republic office@czechsportaircraft.com
No. SB-CR-046		Rev.: -
Date: 2018-02-28		Date: -
Page: 1 of 7

MODEL AFFECTED:	PS-28 Cruiser, SportCruiser / PiperSport – operating under EASA
SUBJECT:	Inspection and/or replacement of oil filter of ROTAX Engine Type 912 S2 / 912 ULS2
AIRCRAFT AFFECTED:	<ul style="list-style-type: none"> - All aircraft the engine of which has been equipped with an oil filter part no. 825016 (with a production date code from 10/17 up to 38/17) during the engine repair, maintenance or general overhaul within the period as of 08 June 2017 till 31 October 2017, inclusive and that have no green mark, see Fig.1. - All oil filters part no.825016 purchased and installed as a spare part during the period from 08 June 2017 till 31 October 2017, inclusive with a production date code from 10/17 up to 38/17.
COMPLIANCE:	<ul style="list-style-type: none"> - Immediately, on uninstalled engines / spare parts. - Before the initial installation into an aircraft and/or before the initial start-up thereafter. - Before next flight: In case of a leakage in the area of the

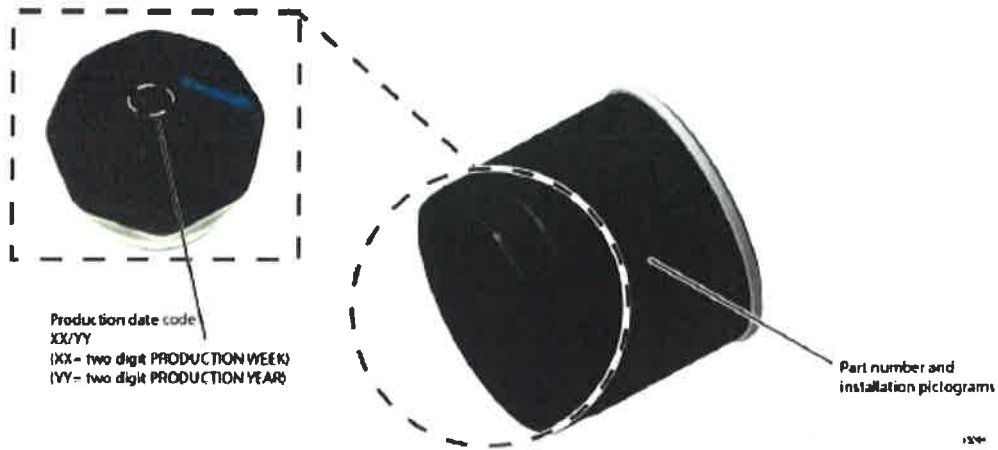
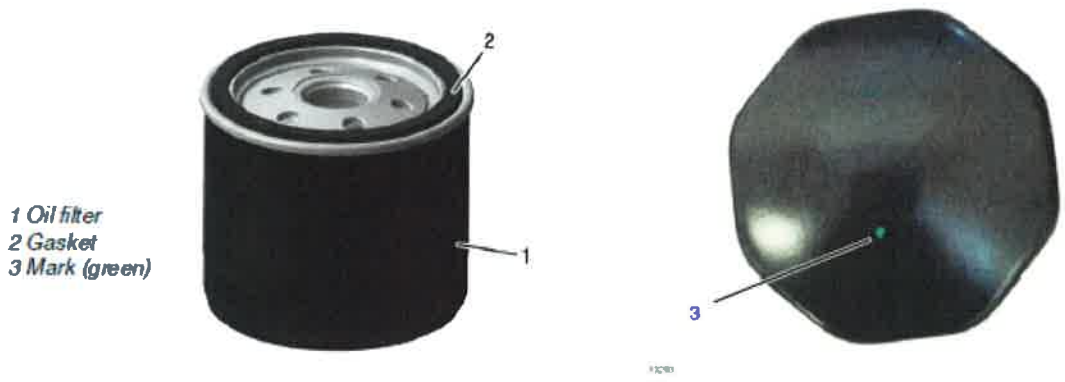
Fig. 1
 Oil filter

Due to deviations in the manufacturing process of the oil filter gasket, cracks in the gasket may have occurred. In rare cases, these deficiencies might lead to oil leakage in the area of the oil filter gasket.

Step	Procedure
1	Check the engine logbook and maintenance documentation or shipping documents to see if this Service Bulletin has already been accomplished.
2	<p>Check whether the affected oil filter shows a green mark on the crown of oil filter (as illustrated in Fig. 1) (same area as production date code).</p> <ul style="list-style-type: none"> - green mark is present: this oil filter is OK as it has already been tested by the supplier and can be used even though the production date code is from 10/17 to 38/17. No further actions are required. - green mark NOT present: this oil filter is NOT OK, please follow the instructions in section Replacement of NOT OK oil filter ... <p>NOTE: If production date code is not easy to read, use a proper means of light (e.g. flashlight directed at a proper angle onto the oil filter crown etc.) for better visibility of the coding imprint.</p>

Step	Procedure
1	Remove the affected oil filter according to the Maintenance Manual Line.
2	Install the new oil filter according to the Maintenance Manual Line.

Step	Procedure
1	Quarantine and/or remove affected filters from your inventory. Mark as unserviceable and return F.O.B. to your ROTAX [®] Authorized Distributor or their independent Service Centers.
