CZECH SPORT
AIRCRAFT

SERVICE BULLETIN

No.: SB-CR-075

MODEL AFFECTED:	PS-28 Cruiser SportCruiser / PiperSport aircraft operating under EASA rules
SUBJECT:	Inspection and eventual replacement of carburetor circlip for Rotax engine type 912 (Series)
AIRCRAFT AFFECTED:	<p>All aircraft with Rotax engine types 912 Series if at least one of the A), B) or C) below mentioned criteria applies.</p> <p>Criterion A) Engine serial number:</p> <p style="padding-left: 40px;">From S/N 6784306 up to S/N 6787000 inclusive From S/N 9565001 up to S/N 9573266 inclusive From S/N 9573268 up to S/N 9573271 inclusive From S/N 4924905 up to S/N 4925000 inclusive From S/N 9139001 up to S/N 9139252 inclusive From S/N 9563601 up to S/N 9565000 inclusive</p> <p>Criterion B) Carburetors:</p> <p style="padding-left: 40px;">1/3 part. no. 892530: From S/N 145021 up to S/N 191489 inclusive From S/N 191491 up to S/N 191496 inclusive From S/N 191498 up to S/N 191499 inclusive From S/N 191502 up to S/N 191513 inclusive S/N 191515 / S/N 191517</p> <p style="padding-left: 40px;">2/4 part. no. 892535: From S/N 144903 up to S/N 191601 inclusive From S/N 191603 up to S/N 191617 inclusive From S/N 191631 up to S/N 191637 i

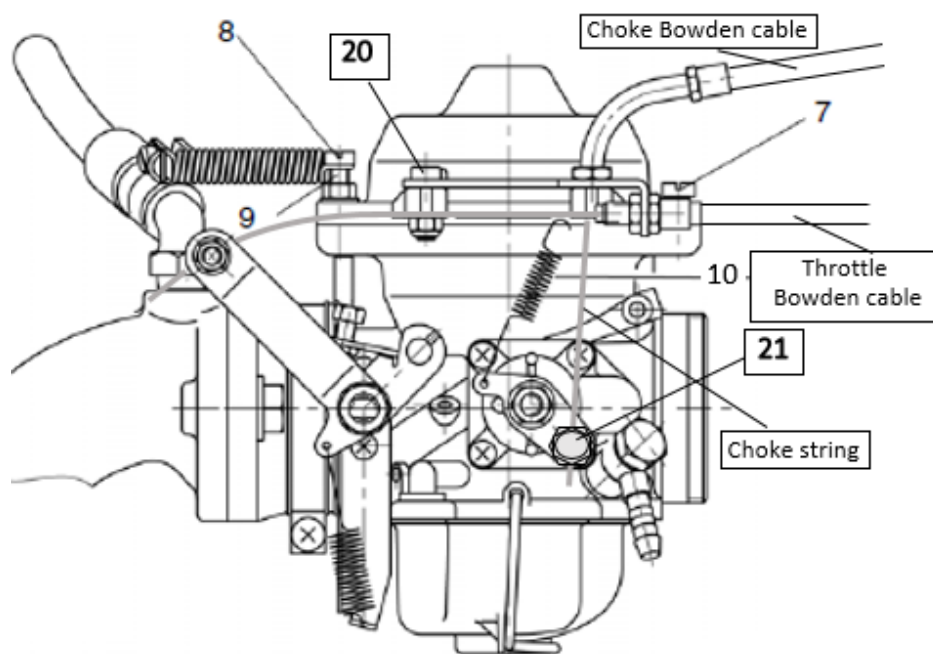
Fig. 1: Rotax 912 carburetor

This Service Bulletin is issued as a result and in consequence to the issue of the Rotax Service Bulletin no. SB-912-073UL and no. SB-912-073. Due to deviations in the Rotax engine manufacturing process a partial fracture of the circlip may occur. This fracture might lead to a crack/ total fracture of the circlip which in consequence may lead to a mal-function of the carburetor. Possible effects might be rough engine running or an unusual engine operating behavior.

1. Check the aircraft / engine logbook and maintenance documentation, if this Service Bulletin has already been accomplished.
2. Check the criteria given in Section "AIRCRAFT AFFECTED", if the aircraft is affected by this Service Bulletin.
3. Move the aircraft to a suitable place to perform the work.
4. Remove the engine upper cowling (see the CR-MM-1-0-00, the latest revision).
5. Disconnect the battery terminals (see the CR-MM-1-0-00, the latest revision).
6. Remove the oval head screw (20), see Fig. 1.
7. Loose the choke screw (21) and release the choke control string, see Fig. 1.
8. Cut the tapes fixing throttle and choke Bowden cables.

9. The carburetor circlips part no. 945785 must be replaced by carburetor circlips part no. 945786. For replacement, follow instructions in the Supplement CR-MM-1-0-00-S-07 (see also the ROTAX Service Bulletin no. SB-912-073).
10. Screw and fix the oval head screw (20), see Fig. 1.
11. Install the choke control string and fix the choke screw (21), see Fig. 1.
12. Use fixing tapes and attach and fix the throttle and choke Bowden cables.
13. Adjust the choke control string, see the CR-MM-1-0-00, Point 10.4, latest revision.
14. Connect the aircraft battery terminals.
15. Install the engine upper cowling (see the CR-MM-1-0-00, latest revision).
