CRUISER
AIRCRAFT

No.: SB-CR-092

SERVICE BULLETIN

MODEL AFFECTED:	PS-28 Cruiser / PS-28N Cruiser SportCruiser / PiperSport operating under EASA rules
SUBJECT:	Reinforcement of the fuselage around the main landing gear
AIRCRAFT AFFECTED:	All PS-28 Cruiser and PS-28N Cruiser aircraft All SportCruiser / PiperSport operating under EASA rules
COMPLIANCE:	According to the owner's decision

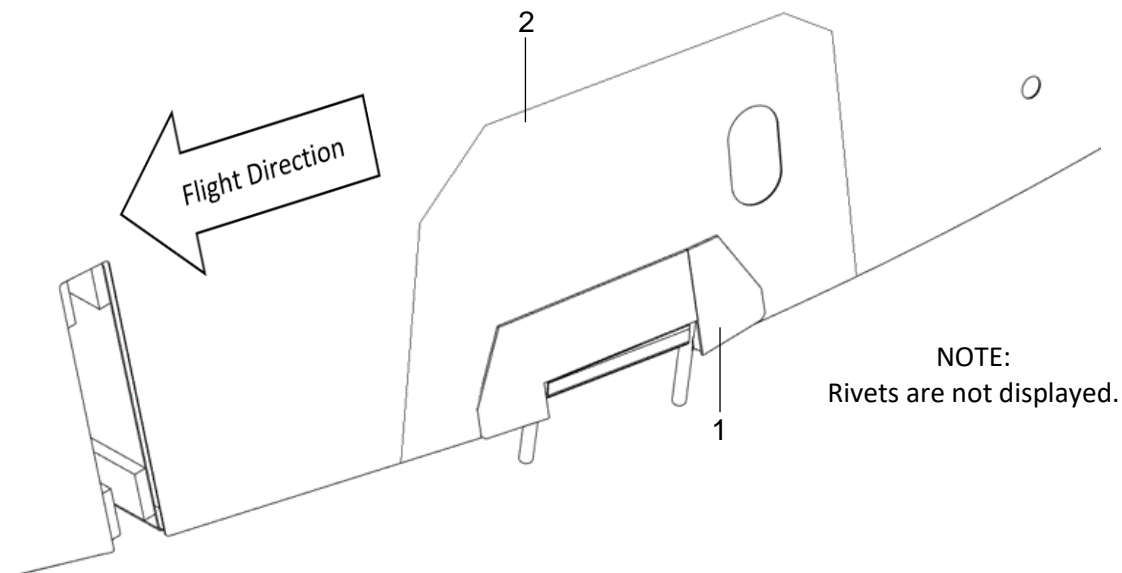
2 Patch
 Fig. 4: Patch installed

1 Main gear attachment

- 5) Remove the main gear attachment (1,2 Fig. 4).
- 6) Install the patch to the place and drill the holes for rivets (002, 003, 004, 005, 006).
- 7) Rivet the patch (001). See the Fig. 2 and Fig. 3 for rivets. Rivet 002 is circle, 003 is square, 004 is triangle, 005 is cross and 006 is pentagon. The approximate position of the patch is marked with a black line. Patch and Main Gear Attachment must be glued with glue (008).
- 8) Install the new main gear attachment (007) to the original position.
- 9) Drill holes for rivets and screws to the main gear attachment.
- 10) Attach the main gear attachment with rivets and screws.
- 11) Install the main landing gear leg (see MM, Chapter 8).
- 12) Install the wing (see MM, Chapter 4).
- 13) Restore the aircraft to airworthy condition.
- 14) Update aircraft records to reflect compliance with this Service Bulletin.
