CRUISER
AIRCRAFT

No.: SB-CR-104

SERVICE BULLETIN

MODEL AFFECTED:	PS-28 Cruiser / PS-28N Cruiser SportCruiser / PiperSport operating under EASA rules
SUBJECT:	Accomplishment of ROTAX Bulletin SB-912-078UL / SB-912-078. Exchange of propeller shaft on ROTAX Engine Type 912S and 912ULS
AIRCRAFT AFFECTED:	All aircrafts with 912 S and 912 ULS engines.
COMPLIANCE:	<ul style="list-style-type: none">- Before next flight check the magnetic plug according to the latest Maintenance Manual Line (MML). If the magnetic plug indicates a good condition of the gearbox, it is allowed to repeat this inspection every 10 hours up to 50 hours of engine TSN. At latest, at 50 hours of engine TSN carry out this exchange of the propeller shaft on the engines listed in Appendix 01, according to the Accomplishment instructions.- Exchange the propeller shaft on engines prior to initial installation. Return affected spare parts to authorized service partner.- On engines, gearbox assy. and propeller shaft, prior to delivery.

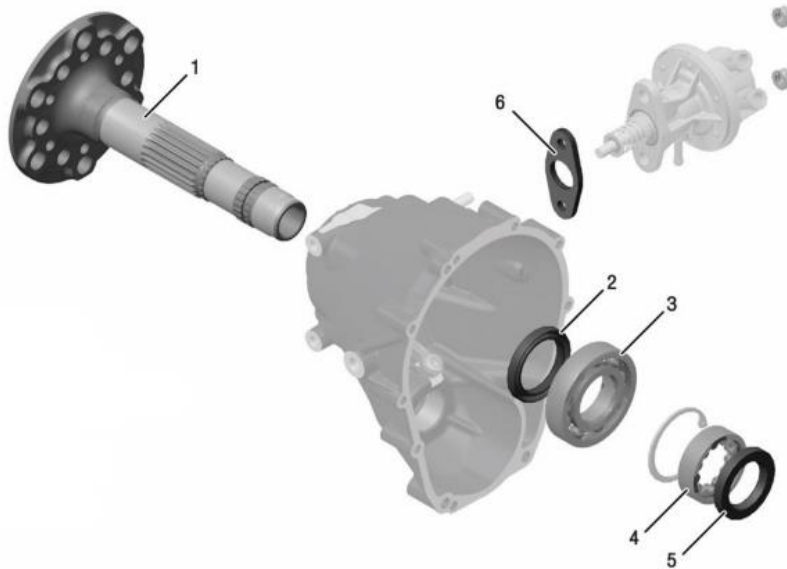
Fig. 2: Propeller shaft

Due to a deviation in the machining process of the propeller shaft, the affected batch shows abnormalities on the surface. This could lead to increased wear of the propeller shaft bearings and subsequent serious engine problems.

- 1) Check the criteria given on page 1, if the aircraft engine is affected by this SB.
- 2) Check the engine logbook and maintenance documentation, if this SB has already been accomplished.
- 3) Move the aircraft to a place suitable to perform the work.
- 4) Following instructions in the current Maintenance Manual Heavy (MMH) and Maintenance Manual Line (MML), perform the following tasks:
 - Remove gearbox assy. from the engine.
 - Disassemble gearbox and press out affected propeller shaft.
 - Reassemble the gearbox using a new propeller shaft, oil seal and ball bearing.
 - Remove crankcase side propeller shaft roller bearing and oil seal and replace with new.
 - Attach gearbox assy. to crankcase.
 - In the case of an engine installed in an aircraft, perform an engine test run.
