CZECH SPORT AIRCRAFT	<h1>SERVICE BULLETIN</h1> <div style="border: 1px solid red; padding: 5px; display: inline-block; margin: 10px 0;"> <h2 style="margin: 0;">MANDATORY</h2> </div>	Czech Sport Aircraft a.s. Na Záhonech 212 686 04 Kunovice Czech Republic info@czechsportaircraft.com
		No.: SB-SC-076
		Date: 2019-09-27
		Page: 1 of 4
		Rev.: - Date: -

MODEL AFFECTED:	SportCruiser / PiperSport (excluding those operating under EASA rules)
SUBJECT:	Inspection and eventual replacement of carburetor circlip for Rotax engine type 912 (Series)
AIRCRAFT AFFECTED:	<p>All SportCruiser / PiperSport aircraft with Rotax engine types 912 Series if at least one of the A), B) or C) below mentioned criteria applies.</p> <p>Criterion A) Engine serial number:</p> <p style="padding-left: 40px;">From S/N 6784306 up to S/N 6787000 inclusive From S/N 9565001 up to S/N 9573266 inclusive From S/N 9573268 up to S/N 9573271 inclusive From S/N 4924905 up to S/N 4925000 inclusive From S/N 9139001 up to S/N 9139252 inclusive From S/N 9563601 up to S/N 9565000 inclusive</p> <p>Criterion B) Carburetors:</p> <p style="padding-left: 40px;">1/3 part. no. 892530: From S/N 145021 up to S/N 191489 inclusive From S/N 191

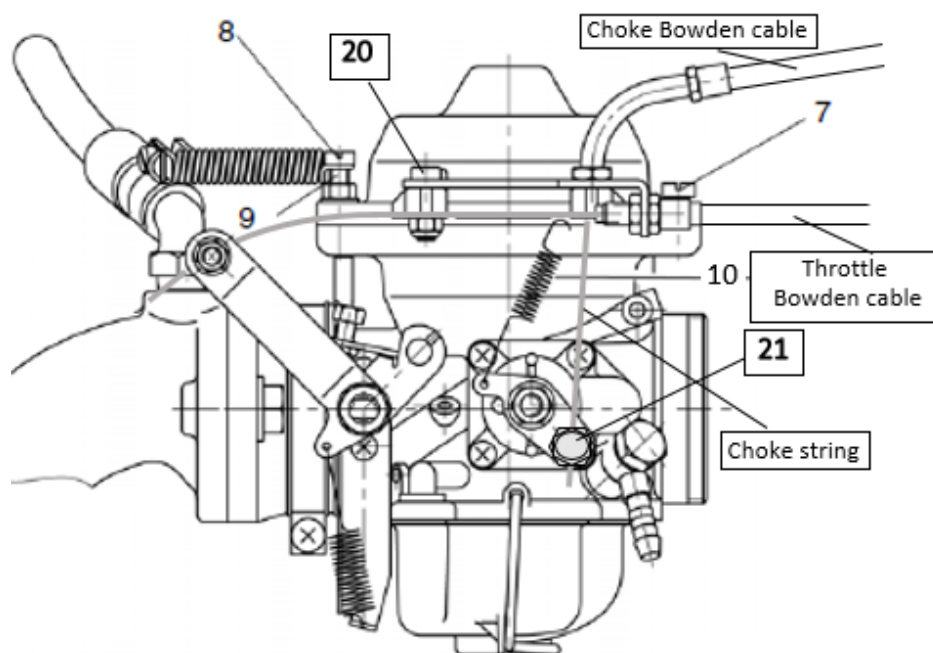
Fig. 0: Rotax 912 carburetor

This Service Bulletin is issued as a result and in consequence to the issue of the Rotax Service Bulletin no. SB-912-073UL and no. SB-912-073. Due to deviations in the Rotax engine manufacturing process a partial fracture of the circlip may occur. This fracture might lead to a crack/ total fracture of the circlip which in consequence may lead to a mal-function of the carburetor. Possible effects might be rough engine running or an unusual engine operating behavior.

1. Check the aircraft / engine logbook and maintenance documentation, if this Service Bulletin has already been accomplished.
2. Check the criteria given in Section "AIRCRAFT AFFECTED", if the aircraft is affected by this Service Bulletin.
3. Move the aircraft to a suitable place to perform the work.
4. Remove the engine upper cowling (see the SC-AMM-1-0-00, the latest revision).
5. Disconnect the battery terminals (see the SC-AMM-1-0-00, the latest revision).
6. Remove the oval head screw (20), see Fig. 0.
7. Loose the choke screw (21) and release the choke control string, see Fig. 0.
8. Cut the tapes fixing throttle and choke Bowden cables.

9. Follow instructions in the ROTAX Service Bulletin no. SB-912-073.
10. Screw and fix the oval head screw (20), see Fig. 0.
11. Install the choke control string and fix the choke screw (21), see Fig. 0.
12. Use fixing tapes and attach and fix the throttle and choke Bowden cables.
13. Adjust the choke control string, see the SC-AMM-1-0-00, Point 10.4, the latest revision.
14. Connect the aircraft battery terminals.
15. Install the engine upper cowling (see the SC-AMM-1-0-00, the latest revision).
16. Restore the aircraft to the airworthy condition.
17. Perform engine run test (see the SC-AMM-1-0-00, the latest revision).
18. Complete the aircraft records (log book) to reflect compliance with this Service Bulletin.
19. Thereby, the performance of this Service Bulletin is completed.
