CRUISER
AIRCRAFT

No.: SB-SC-078

SERVICE BULLETIN

| SUBJECT: | Rudder stops replacement |

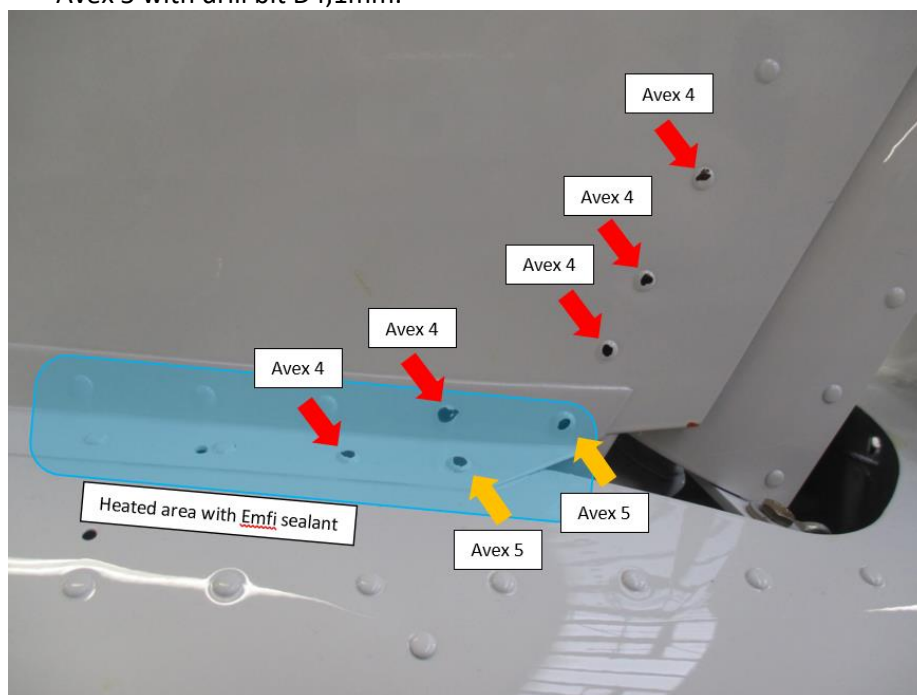
Fig. 1: Rivets marked to be drilled out

- 1) Remove horizontal stabilizer (SC_MM-1-0-00, Chap 5.3), disconnect trim wires and elevator rod.
- 2) Remove rudder (SC-MM-1-0-00, Chap 5.3), disconnect control cables.
- 3) Drill out the rivets both sides (SC-MM-1-0-00, Chapter 15.2). All drilled rivets are marked on the picture (Fig. 1). Rivets marked as Avex 4 with drill bit D3,2mm and Avex 5 with drill bit D4,1mm.

- 8) Install the left and the right stop, keep stops in contact with the mounting device.
- 9) Drill the holes, D3,2mm for Avex 4 and D4,1mm for Avex 5, see Fig. 1.

- 13) Gradually rivet (SC-MM-1-0-00, Chap 15.3) the rivets Avex 4-10 pcs. and Avex 5-4 pcs. See Fig. 1.
- 14) Remove the mounting device.
- 15) Clean the airframe from rest of rivets.

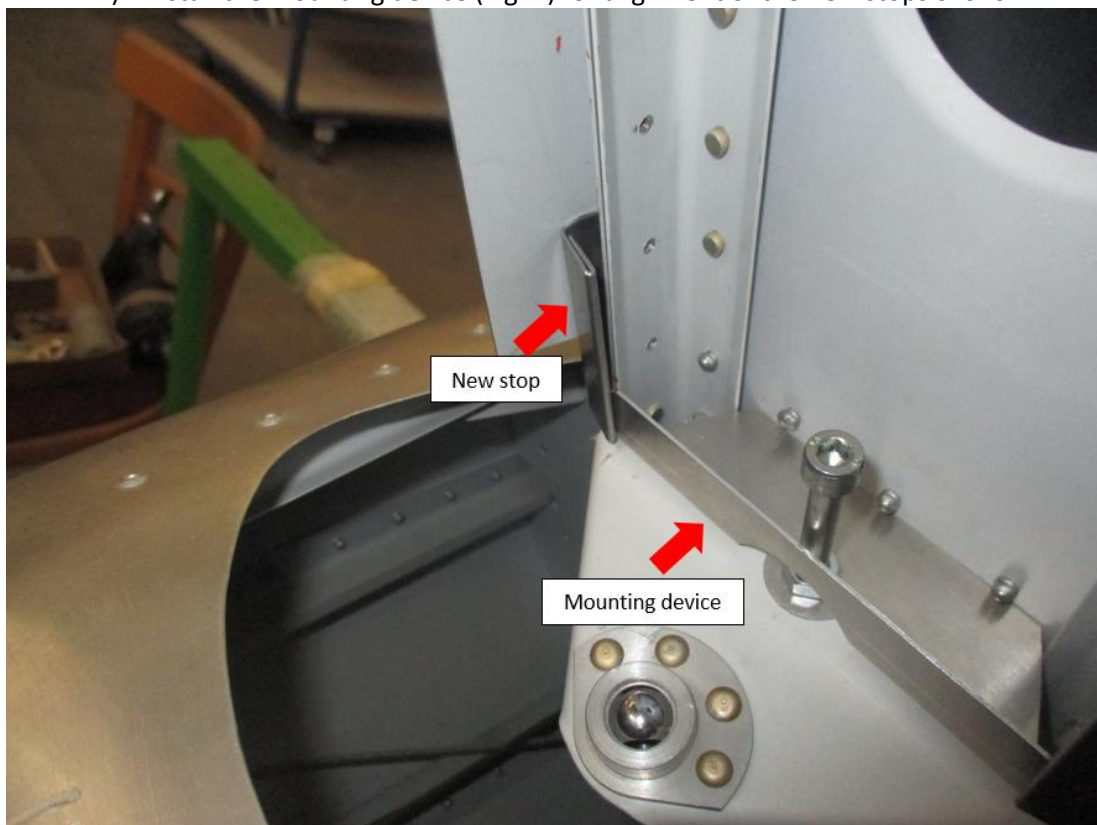
Fig. 2: Mounting device

- 4) Gently heat up the fairing with a hot-air gun in blue area.
- 5) Remove the stops.
- 6) Remove any residual Emfi sealant using a snap blade knife.
- 7) Install the mounting device (Fig. 2) for alignment of the new stops SF0262LP.
