CRUISER
AIRCRAFT

No.: SB-SC-092

SERVICE BULLETIN

MODEL AFFECTED:	SportCruiser / PiperSport operating outside EASA rules
SUBJECT:	Reinforcement of the fuselage around the main landing gear
AIRCRAFT AFFECTED:	All SportCruiser / PiperSport
COMPLIANCE:	According to the owner's decision

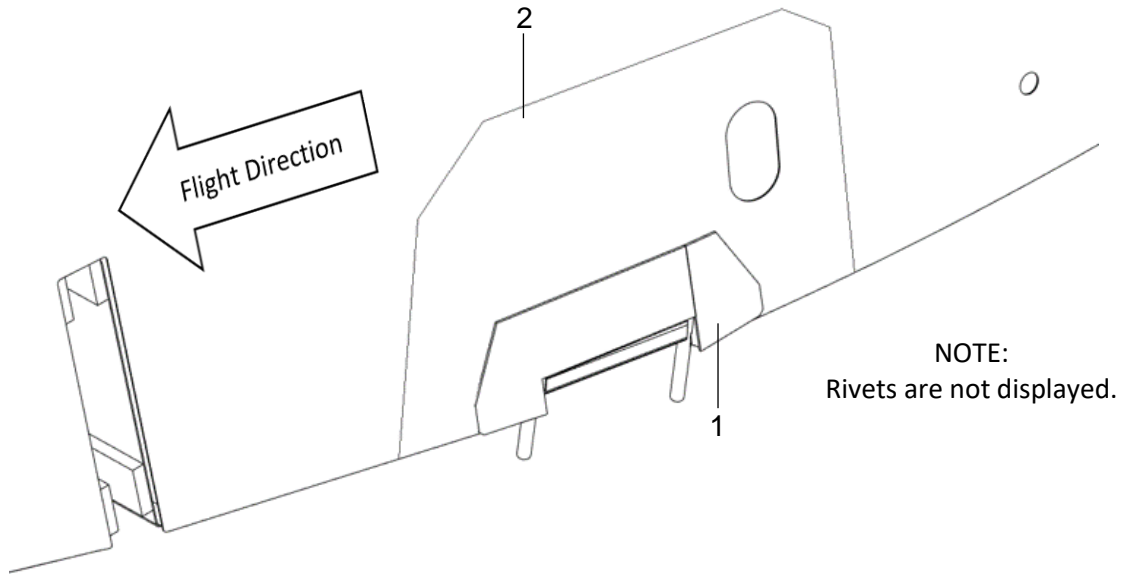
Fig. 3: Patch installed

1 Main gear attachment

2 Patch

- 5) Remove the main gear attachment (1,2 Fig. 3).
- 6) Install the patch to the place and drill the holes for rivets (002, 003, 004, 005, 006).
- 7) Rivet the patch (001). See the Fig. 2 and Fig. 3 for rivets. Rivet 002 is circle, 003 is square, 004 is triangle, 005 is cross and 006 is pentagon. The approximate position of the patch is marked with a black line. Patch and Main Gear Attachment must be glued with glue (008).
- 8) Install the new main gear attachment (007) to the original position.
- 9) Drill holes for rivets and screws to the main gear attachment.
- 10) Attach the main gear attachment with rivets and screws.
- 11) Install the main landing gear leg (see AMM, Chapter 8).
- 12) Install the wing (see AMM, Chapter 4).
- 13) Restore the aircraft to airworthy condition.
- 14) Update aircraft records to reflect compliance with this Service Bulletin.
