CRUISER
AIRCRAFT

No.: SB-SC-095

SERVICE BULLETIN

MODEL AFFECTED:	SportCruiser / PiperSport operating outside EASA rules
SUBJECT:	Replace fuel quantity sensor
AIRCRAFT AFFECTED:	All SportCruiser / PiperSport aircraft up to S/N C0416
COMPLIANCE:	Apply this Service Bulletin when replace of AST 250489 fuel quantity sensor is needed

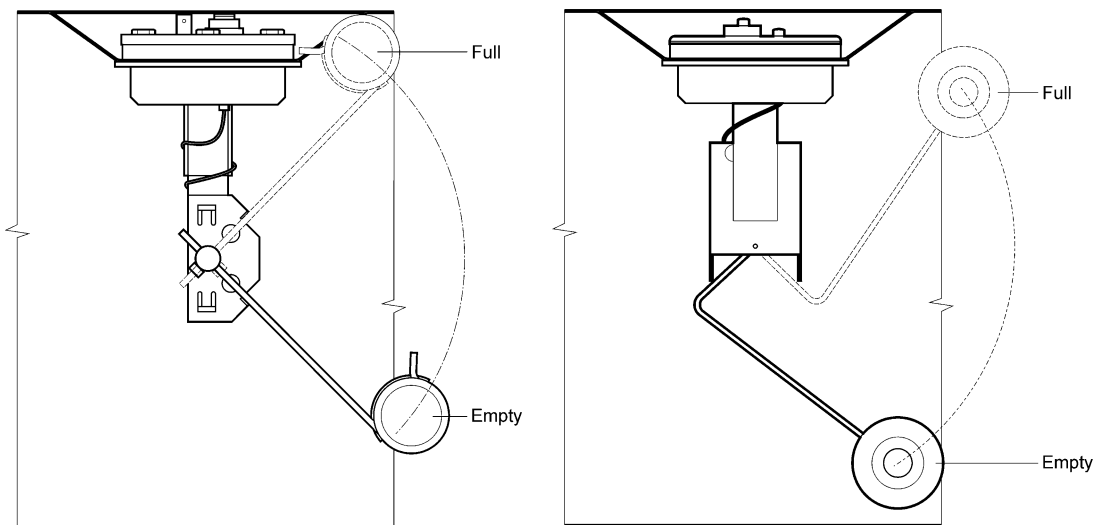
Fig. 1: Float mechanism

SPORTCRUISER / PIPERSPORT AIRPLANES UP TO S/N C0416

SPORTCRUISER AIRPLANES FROM S/N C0416

- 6) Remove old sensor. Take a note or picture of electrical connection for further sensor installation (see AMM, Chapter 9).

- 7) Clean flange of the tank.
- 8) Install the new fuel quantity sensor and connect all connectors.
- 9) Use new bolts and washers. Bolts secure with Loctite.
