CRUISER  
AIRCRAFT

No.: SB-SC-102

# SERVICE BULLETIN

| <b>SUBJECT:</b> | Accomplishment of ROTAX Bulletin SB-912-078UL / SB-912-078. Exchange of propeller shaft on ROTAX Engine Type 912S and 912ULS |

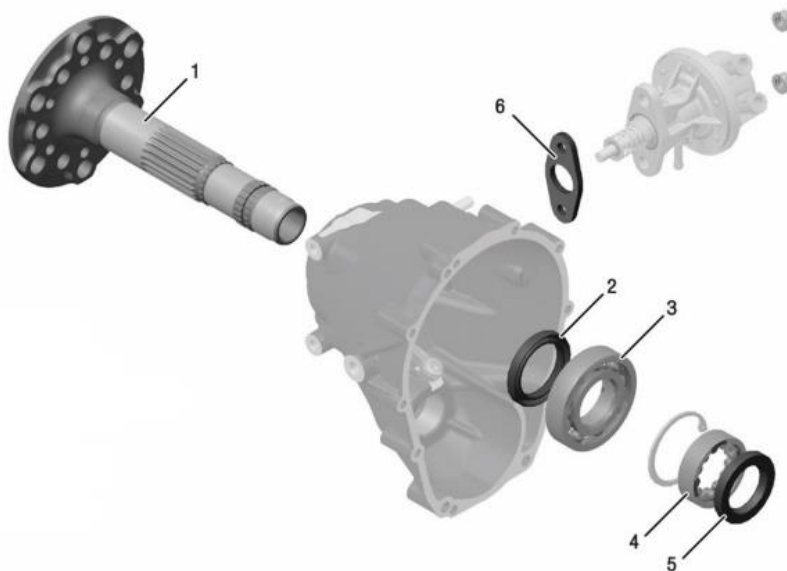
Fig. 2: Propeller shaft

- 1 Propeller shaft
- 2 Oil seal 40x55x7
- 3 Ball bearing 35-72-17
- 4 Roller bearing
- 5 Oil seal 30x52x7
- 6 Isolating flange

- 1) Check the criteria given on page 1, if the aircraft engine is affected by this SB.
- 2) Check the engine logbook and maintenance documentation, if this SB has already been accomplished.
- 3) Move the aircraft to a place suitable to perform the work.
- 4) Following instructions in the current Maintenance Manual Heavy (MMH) and Maintenance Manual Line (MML), perform the following tasks:
  - Remove gearbox assy. from the engine.
  - Disassemble gearbox and press out affected propeller shaft.
  - Reassemble the gearbox using a new propeller shaft, oil seal and ball bearing.
  - Remove crankcase side propeller shaft roller bearing and oil seal and replace with new.
  - Attach gearbox assy. to crankcase.
  - In the case of an engine installed in an aircraft, perform an engine test run.
