CRUISER
AIRCRAFT

No.: SB-SC-103

SERVICE BULLETIN

MODEL AFFECTED:	SportCruiser / PiperSport operating outside EASA rules
SUBJECT:	Accomplishment of ROTAX Bulletin SB-912-077UL / SB-912-077. Exchange of stator assy. for ROTAX 912 Aircraft Engines.
AIRCRAFT AFFECTED:	All aircrafts with 912 S and 912 ULS engines.
COMPLIANCE:	-On undelivered engines prior to delivery -Before the initial installation in an aircraft and/or spare part -Carry out this exchange of the stator on the engines listed in APPLICABILITY, according to the instructions in section 3 at the next ROTAX scheduled maintenance event, but at the latest after 1 year (from the date of the initial issue of this SB) These maintenance instructions shall be considered at any maintenance events, retrofitting, repair and overhaul.

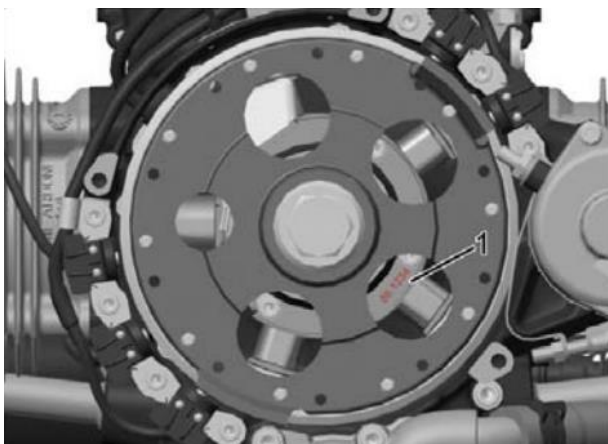
Fig. 3: Stator

NOTE: The stator's serial number can be viewed by rotating the flywheel hub until a lightening hole is aligned at approximately 4 o'clock position.

NOTE: Turn the propeller slowly in the direction of normal rotation until the stator serial number is visible through one of the larger flywheel hub lightening holes.

- 1) Check the criteria given on page 1, if the aircraft engine is affected by this SB.
- 2) Check the engine logbook and maintenance documentation, if this SB has already been accomplished.
- 3) Move the aircraft to a place suitable to perform the work.
- 4) Check the serial number. See Fig. 3.
