CRUISER
AIRCRAFT

No.: SB-SC-105

SERVICE BULLETIN

MODEL AFFECTED:	SportCruiser / PiperSport operating outside EASA rules
SUBJECT:	Tiedown ring reinforcement
AIRCRAFT AFFECTED:	All SportCruiser / PiperSport aircraft operating outside EASA rules
COMPLIANCE:	According to the owner's decision

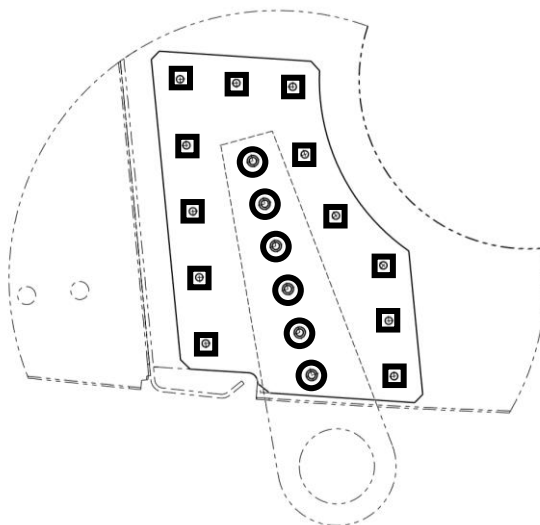
Fig. 1: Tiedown ring with patch

Repair of torn wing tiedown ring.

- 3) Straighten the bent rib.
- 4) Drill small hole at the end of the crack.
- 5) Adjust the damaged skin so that has no sharp edges and corners are shaped into radiuses.
- 6) Fit the tiedown ring (003) and tiedown ring reinforcement (001, Fig. 1 and Fig. 2). Rivet it (004, 005).
