CRUISER AIRCRAFT	<h1>SERVICE BULLETIN</h1>	Czech Aircraft Group s.r.o. Na Záhonech 212 686 04 Kunovice Czech Republic info@cruiseraircraft.com
		Rev.: 1
		Date: 2021-01-28
		No. SB-CR-033
Date: 2016-03-18		
Page: 1 of 10

MODEL AFFECTED:	PS-28 Cruiser SportCruiser / PiperSport - under EASA PtF operation only
SUBJECT:	Change from Cylinder Head Temperature to Coolant Temperature measurement method for aircraft equipped with Rotax 912 ULS and 912 S2 series engine with a new cylinder head design.
AIRCRAFT AFFECTED:	PS-28 Cruiser up to S/N C0556 including SportCruiser – all S/N PiperSport – all S/N
COMPLIANCE:	As per EASA AD 2015-0240 (for Rotax engines)

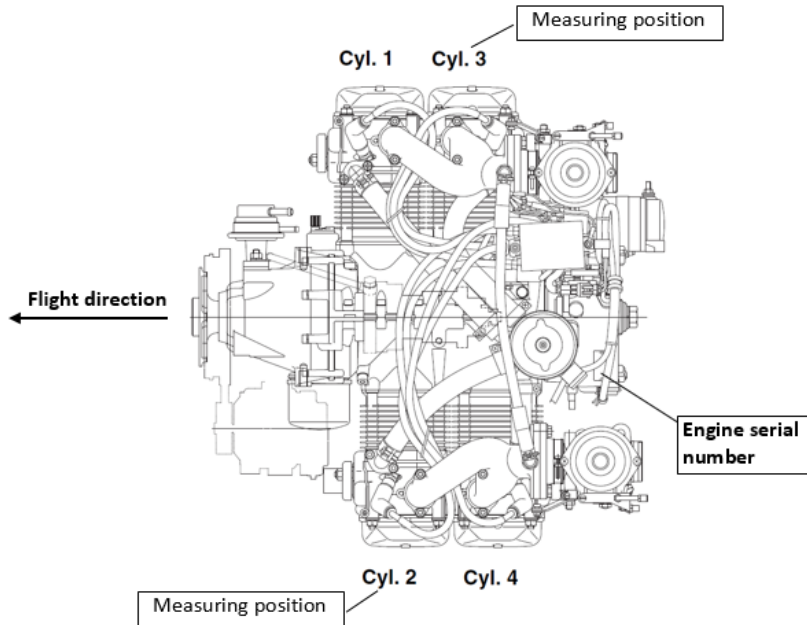
Figure 1 Location of the engine serial number and cylinder head positions

- a) **The engine serial number** is located on the top of the crankcase, magneto side.
 Basic scheme of the Rotax 912 engine with location of engine serial number and cylinder heads positions, see Figure 1.

1. Move the aircraft to a suitable place to perform the work and remove the bottom and upper engine cowlings.
2. Check the engine serial number S/N, if the aircraft is affected by this SB, see Figure 1 above.

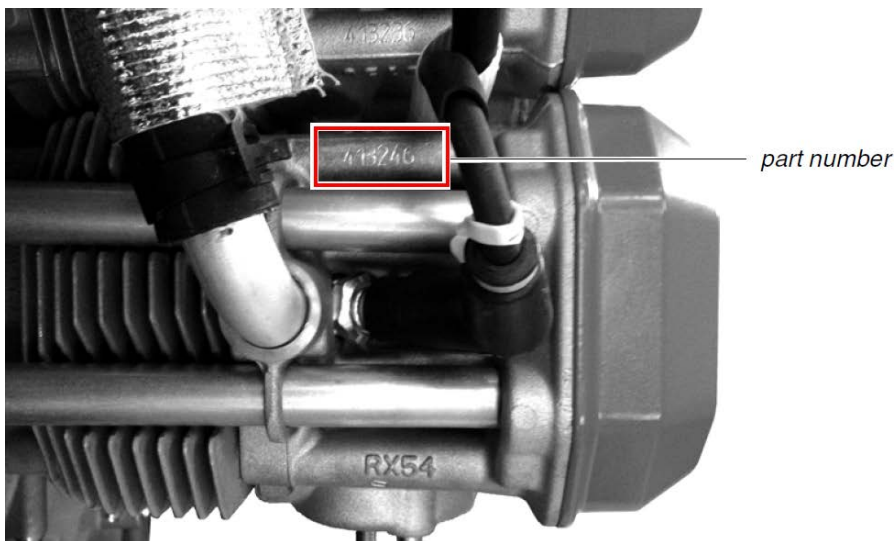
Figure 2 - Part number location of cylinder head

- b) **The temperature sensors** are located on cylinder 2 and 3. To recognize whether the engine is equipped with the new cylinder head design (P/N 413185 for 2/3 cylinder head) or not, read the Part number of the 2/3 cylinder heads, see Figure 2.

3. Check the part numbers of the cylinder heads at the measuring positions 2/3, see Figure 1 and Figure 2 above.
Send a written report to Czech Aircraft Group s.r.o. about the check result (Date, Aircraft S/N, New cylinder heads design was found/not found.)

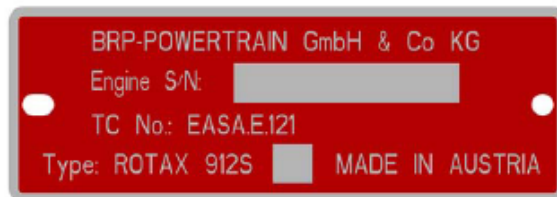
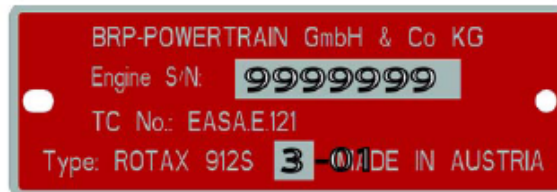
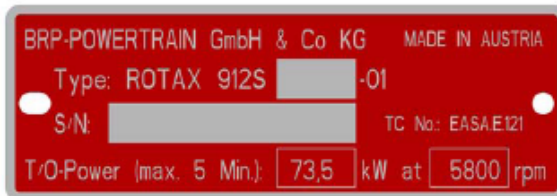
Figure 4 Check of the engine serial number S/N and the suffix -01 on the type plate. (see the whole SB-912-068 R1 from ROTAX for details)

The following suffix may only be added to indicate configuration changes / modifications / overhauls. The remaining content of the type plate must not be changed.

5. In case the **new cylinder heads design** (P/N 413185 at the cylinder head position 2/3) **is found**, check if the suffix-01 on the type plate is present, see Figure 4 below. If the suffix-01 on the type plate is not present, ensure a permanent application of the suffix -01 (e.g. engraved, stamped or similar), see Figure 4.
Note: In case there is only one cylinder head of the new type (P/N 413185) at a single position 2 or 3 installed, ensure at authorized service organization that the cylinder head of the old type on the other position (2 or 3, as applicable) be replaced with a new type of the cylinder head having P/N 413185.
Any changes regarding to this Service Bulletin must be confirmed in the logbook

Step	Procedure
1	Apply suffix - 01 permanently (e.g. engraved, stamped or similar) to the type plate. NOTE: Any changes regarding to this Service Bulletin must be confirmed in the engine logbook.

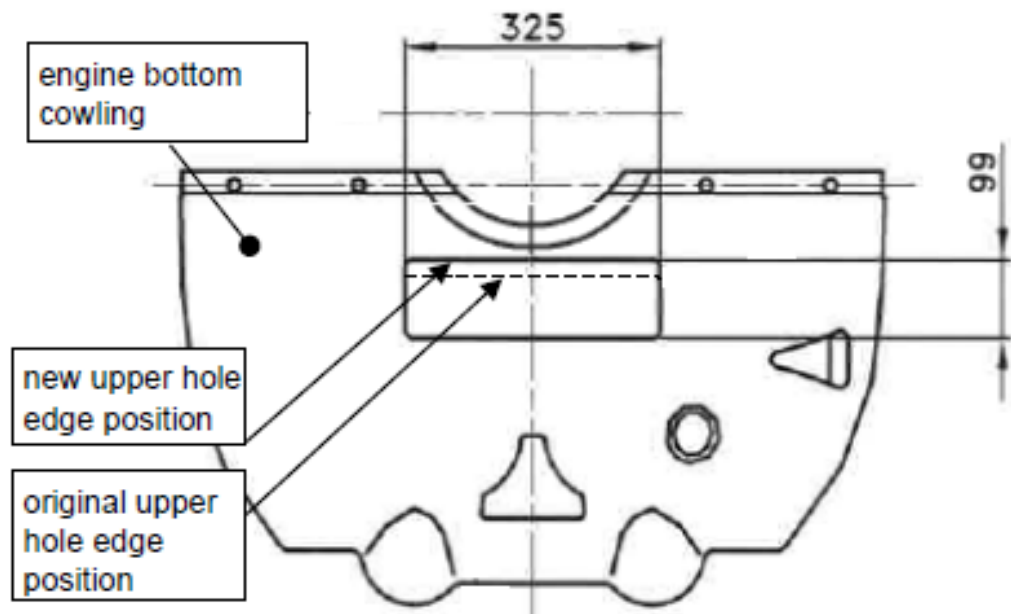
Figure 5 - extension of the air cooler inlet hole in the engine bottom cowling

Due to these changes the Coolant Temperature (CT) instead of the Cylinder Head Temperature (CHT) in the aluminium is displayed. For that reason it is necessary to check/correct the Coolant Temperature limit (120°C) displayed on the instrument panel, check/correct its naming (CT instead of CHT). To improve the engine cooling characteristics, an extension of the air cooler inlet hole in the engine bottom cowling is to be applied.

- 10.1. Use the engine bottom cowling, measure out and mark new hole top edge acc. to the Figure 5 below. The new top edge is moved upwards.
- 10.2. Cut off the top rim accordingly to the marking and clean the hole.
- 10.3. Fit in place and adjust the cut off top rim and laminate it back in the extended cowling inlet hole.
- 10.4. Use an additional fiberglass and apply for laminating of side parts of the cowling hole.
- 10.5. Carry out sanding for good adhesion of the repair coats.
- 10.6. Apply a sufficient primer and top coat to restore the original colour design of the surface.
