CRUISER
AIRCRAFT

No.: SB-SC-083

SERVICE BULLETIN

MODEL AFFECTED:	SportCruiser / PiperSport operating outside EASA rules
SUBJECT:	Backrest wall reinforcement
AIRCRAFT AFFECTED:	All SportCruiser / Piper Sport aircraft
COMPLIANCE:	When the backrest wall crack or bend or buckling occurs

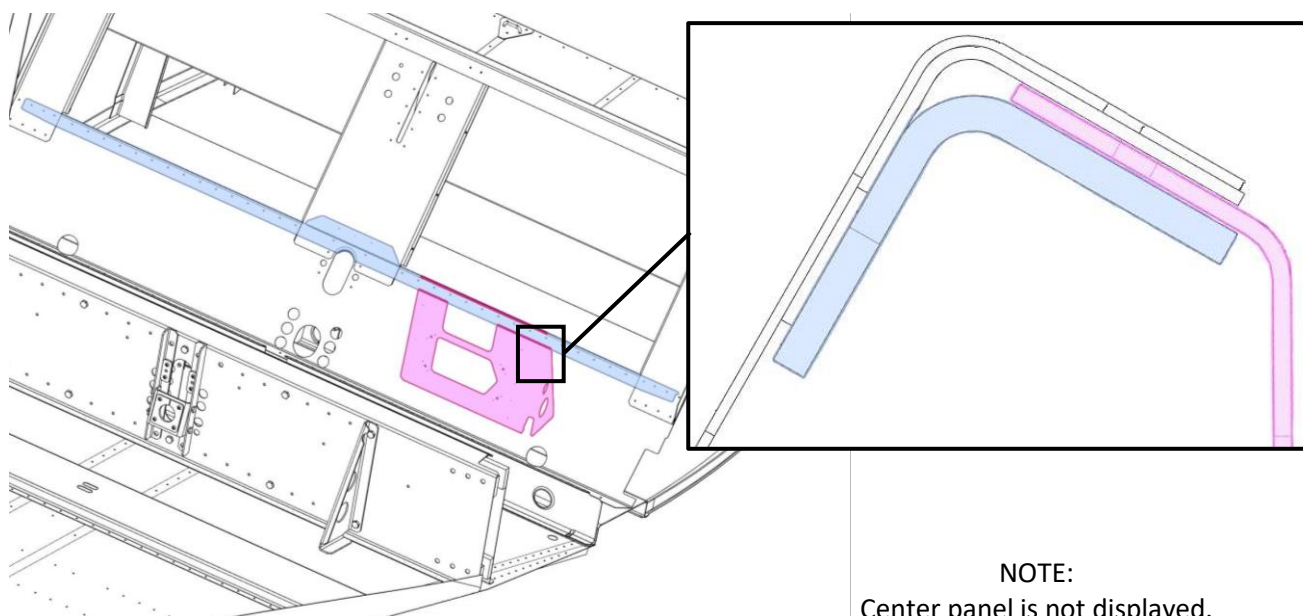
Fig. 1: Backrest wall reinforcement

NOTE:
Center panel is not displayed.

- 1) Move the aircraft to a place suitable to perform the work.
- 2) Fold down the backrests of both seats.
- 3) Unscrew the screws holding the backrests. Remove the backrests and seats.
- 4) Drill out the rivet nuts.
- 5) Drill out the rivets from the edge (blue area). See Fig. 1. Do not drill out the rivets from the center section between seats.
- 6) Straighten the bent parts.
- 7) If there are cracks at the bend, drill the end of the crack.
- 8) It is necessary to drill 2 x \varnothing 6 mm (0,24 in) holes in the lower reinforcement (001) to pass the riveted rivets. See Fig. 2. Measure the exact position on the aircraft.

- 9) Attach the upper (002) and lower (001) reinforcement. Pay close attention to the attachment area of the autopilot bracket (pink area). See Fig. 1.
- 10) Rivets are marked on the Fig. 3.
- 11) Drill \varnothing 4,2 mm (0,16 in) holes for rivets (003).
