CRUISER
AIRCRAFT

SERVICE BULLETIN

No.: SB-SC-085

MODEL AFFECTED:	SportCruiser / PiperSport operating outside EASA rules
SUBJECT:	Substitution of Trail Tech light
AIRCRAFT AFFECTED:	All SportCruiser / PiperSport aircraft
COMPLIANCE:	According to the owner's decision.

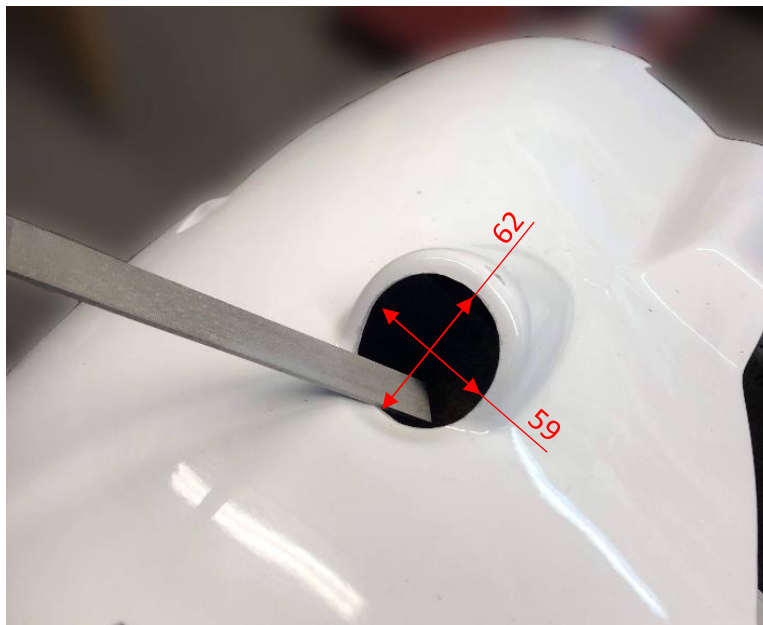
Fig. 2: Oval hole

NOTE: Slight overlap between top of light lens and cowling is acceptable (approx. 5 mm).

- Using a mock-up, drill a 2.5 mm hole. Then drill the hole to a diameter of 5.2 mm.
- Depending on the resulting joint thickness, choose a suitable screw (004 or 005) and a combination of washers (007 and 008).
- Test light (001) and verify the parallelism of the front of the light and the flange in the cowling after tightening the bolt. Due to the tightening of the screw, the parallelism may be broken. In this case, choose another pad.
- If necessary, repeat steps 5 to 7.
- Enlarge the front hole for the light to an oval with dimensions 62x59mm (see Fig. 2).
