CRUISER
AIRCRAFT

No.: SB-CR-100

SERVICE BULLETIN

MODEL AFFECTED:	PS-28 Cruiser / PS-28N Cruiser SportCruiser / PiperSport operating under EASA rules
SUBJECT:	Generator wiring modification
AIRCRAFT AFFECTED:	All PS-28 Cruiser and PS-28N Cruiser aircraft All SportCruiser / PiperSport operating under EASA rules
COMPLIANCE:	According to the owner's decision

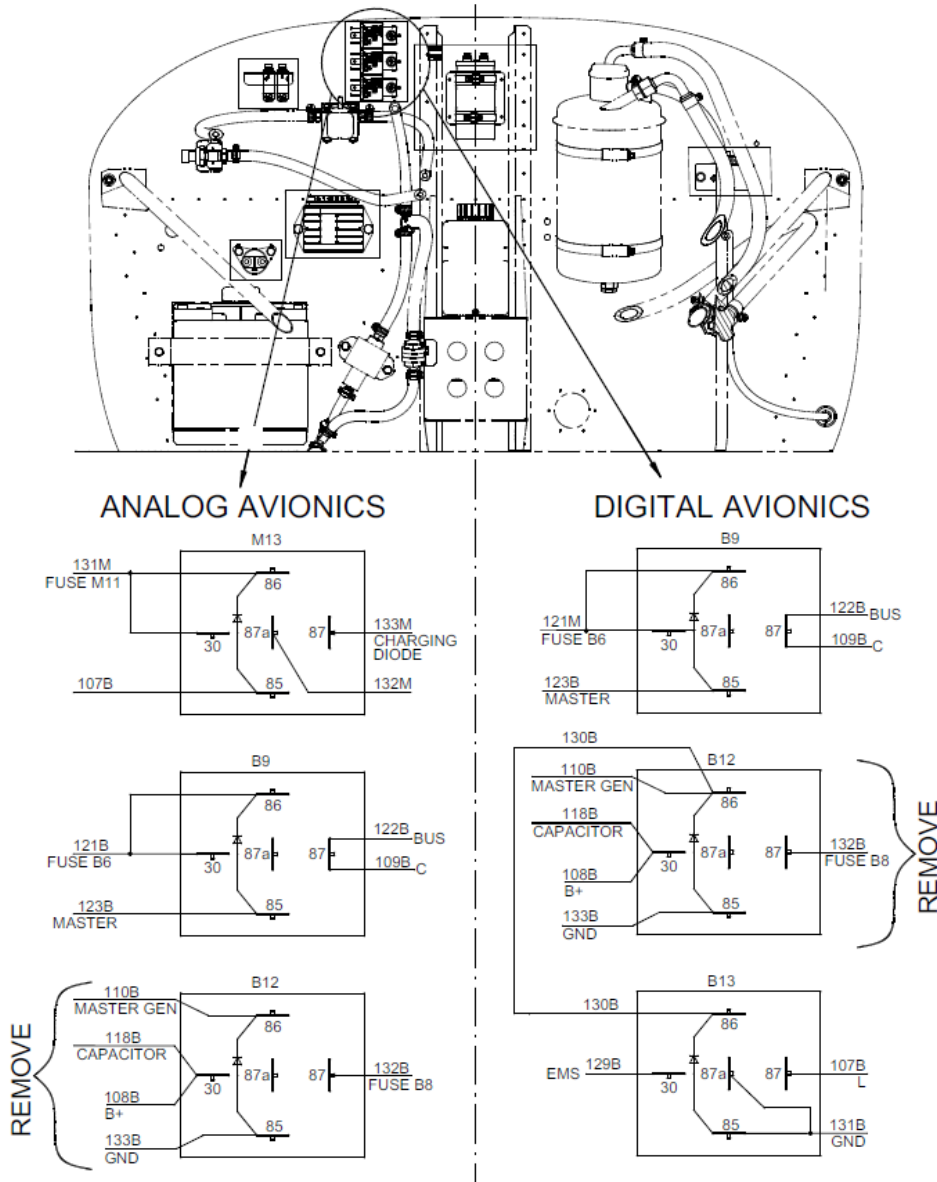
Fig. 1: Condition before modification

CONDITION BEFORE MODIFICATION

NOTE: Airplane S/N from C0637 (inclusive C0630) do not have wire 118B connected to relay B12. See wiring diagram in the end of this document.

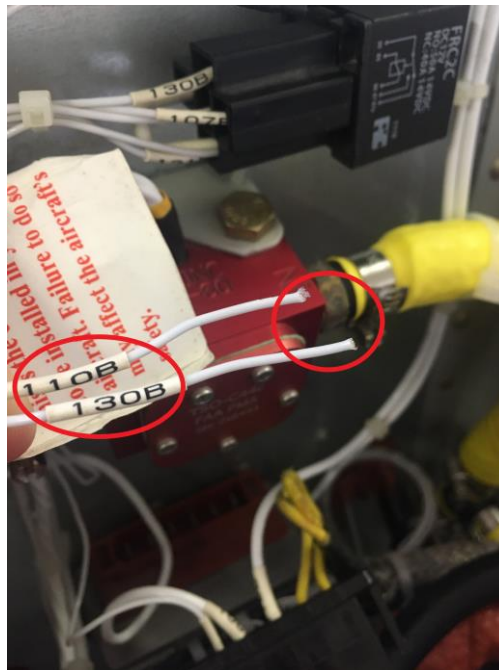
Fig. 25: Wires 110B and 130B

NOTE: Wire 130B is not used for the analog avionics.

23) Cut the terminals from the 110B and 130B wires (See Fig. 25)

NOTE: For airplanes S/N till C0637 (exclusive C0630) wire 118B leads to relay B12. Rewire 118b to R on the rectifier (See diagram in the attachment)

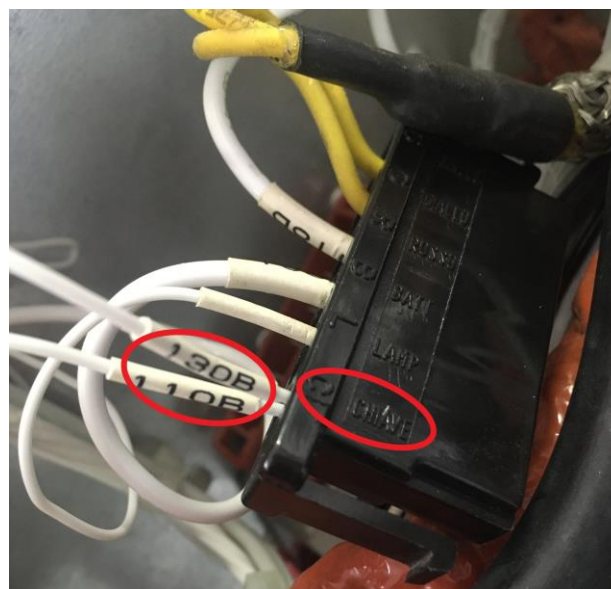
Fig. 28: Terminal block

NOTE: Wire 130B is not used for the analog avionics.

- 26) Insert the connected wires 130B and 110B into the terminal block at position C (See Fig. 28)
