No.: SB-CR-109

SERVICE BULLETIN

MODEL AFFECTED:	IODEL AFFECTED: PS-28 Cruiser / PS-28N Cruiser SportCruiser / PiperSport operating under EASA rules	
SUBJECT:	Inspection of rivets on the firewall	
AIRCRAFT AFFECTED:	IN/NULIABLE chard hart from order No. DUV-2020/1000086	
COMPLIANCE:	Within the next 100 flight hours / annual inspections, whichever occurs first.

This Service Bulletin contain instructions how to inspect and replace non-compliance rivets on the firewall.

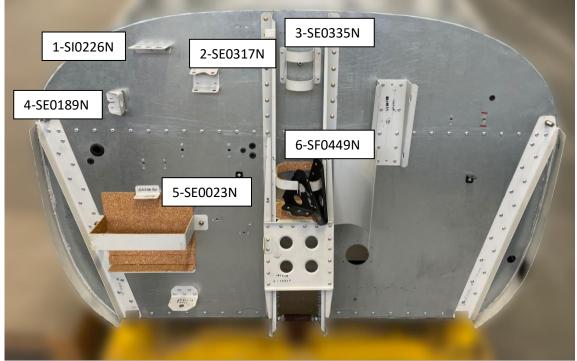
Fig. 1: Firewall

- NOTE: Do not disconnect the fuel hose.
 - 5) Unscrew the relay and remove flow meter on bracket SE0317N (2, Fig. 1).

- 6) Remove the tank at the SF0449N holder (6).
- 7) Inspect rivets on brackets and holders as Fig. 1 shows. Fig. 2 and Fig. 3 can be used as a guidance.

- 9) Remove equipment, hose and wires at the affected parts as needed.
- 10) Drill out non-compliance rivets and replace them with the correct rivets (001).
- 11) Restore the aircraft to airworthy condition.
- 12) Update aircraft records to reflect compliance with this Service Bulletin.

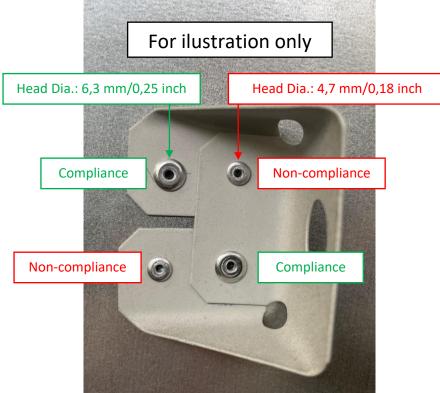
Fig. 2: Illustration of rivets heads

8) If any part has the non-complaining rivets, continue to the point 9). If all rivets are correct, continue to the point 11).
