CRUISER  
AIRCRAFT

No.: SB-SC-104

# SERVICE BULLETIN

<b>MODEL AFFECTED:</b>	SportCruiser / PiperSport operating outside EASA rules
<b>SUBJECT:</b>	Installation of engine cooling system with Silent-Hektik F1209v dual circuit thermostatic valve
<b>AIRCRAFT AFFECTED:</b>	All SportCruiser / PiperSport operating outside EASA rules
<b>COMPLIANCE:</b>	According to the owner's decision.

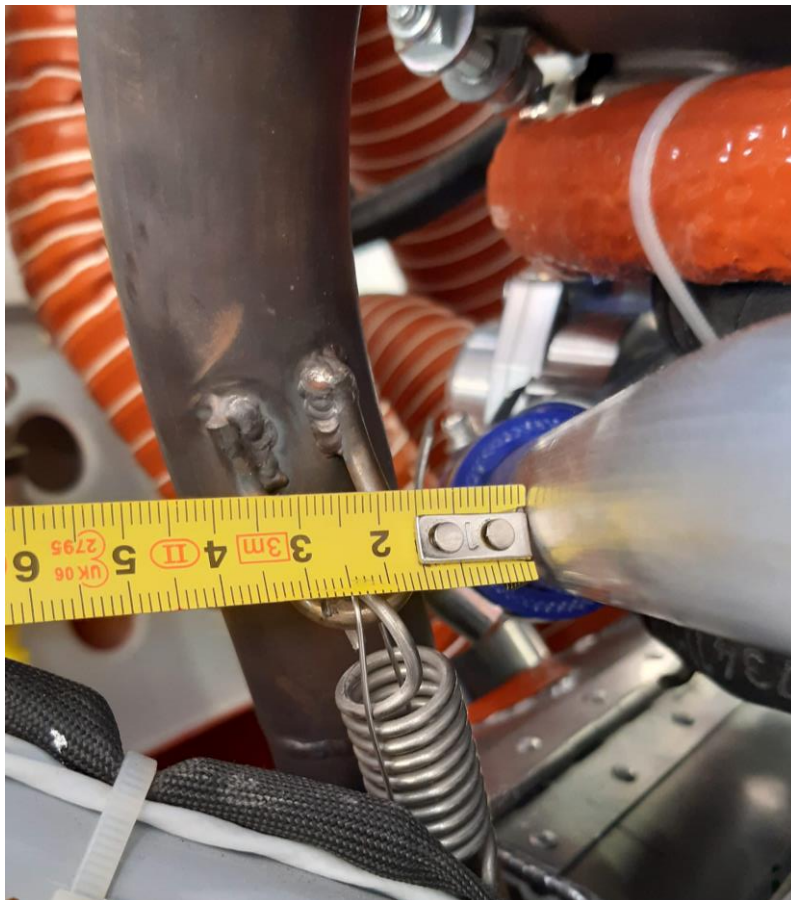
Fig. 16: Typical distance between right tube and right rear exhaust.

- 12) Install back all exhaust components. Secure exhaust spring with wire (item 700).
- 13) Install tubes (item 2, 3, 4). Use blue silicon hoses and elbows as a connecting element (item 9, 10). Each joint has to be secured by hose clamp (item 18). Contact area can be lubricated with drop of fresh coolant liquid for easier slip-on hose on the tubes. Make sure that tubes and hoses are sufficient distance from engine, engine component and engine mount. As a sufficient distance is considered 10 mm. Minimum distance is 5 mm.

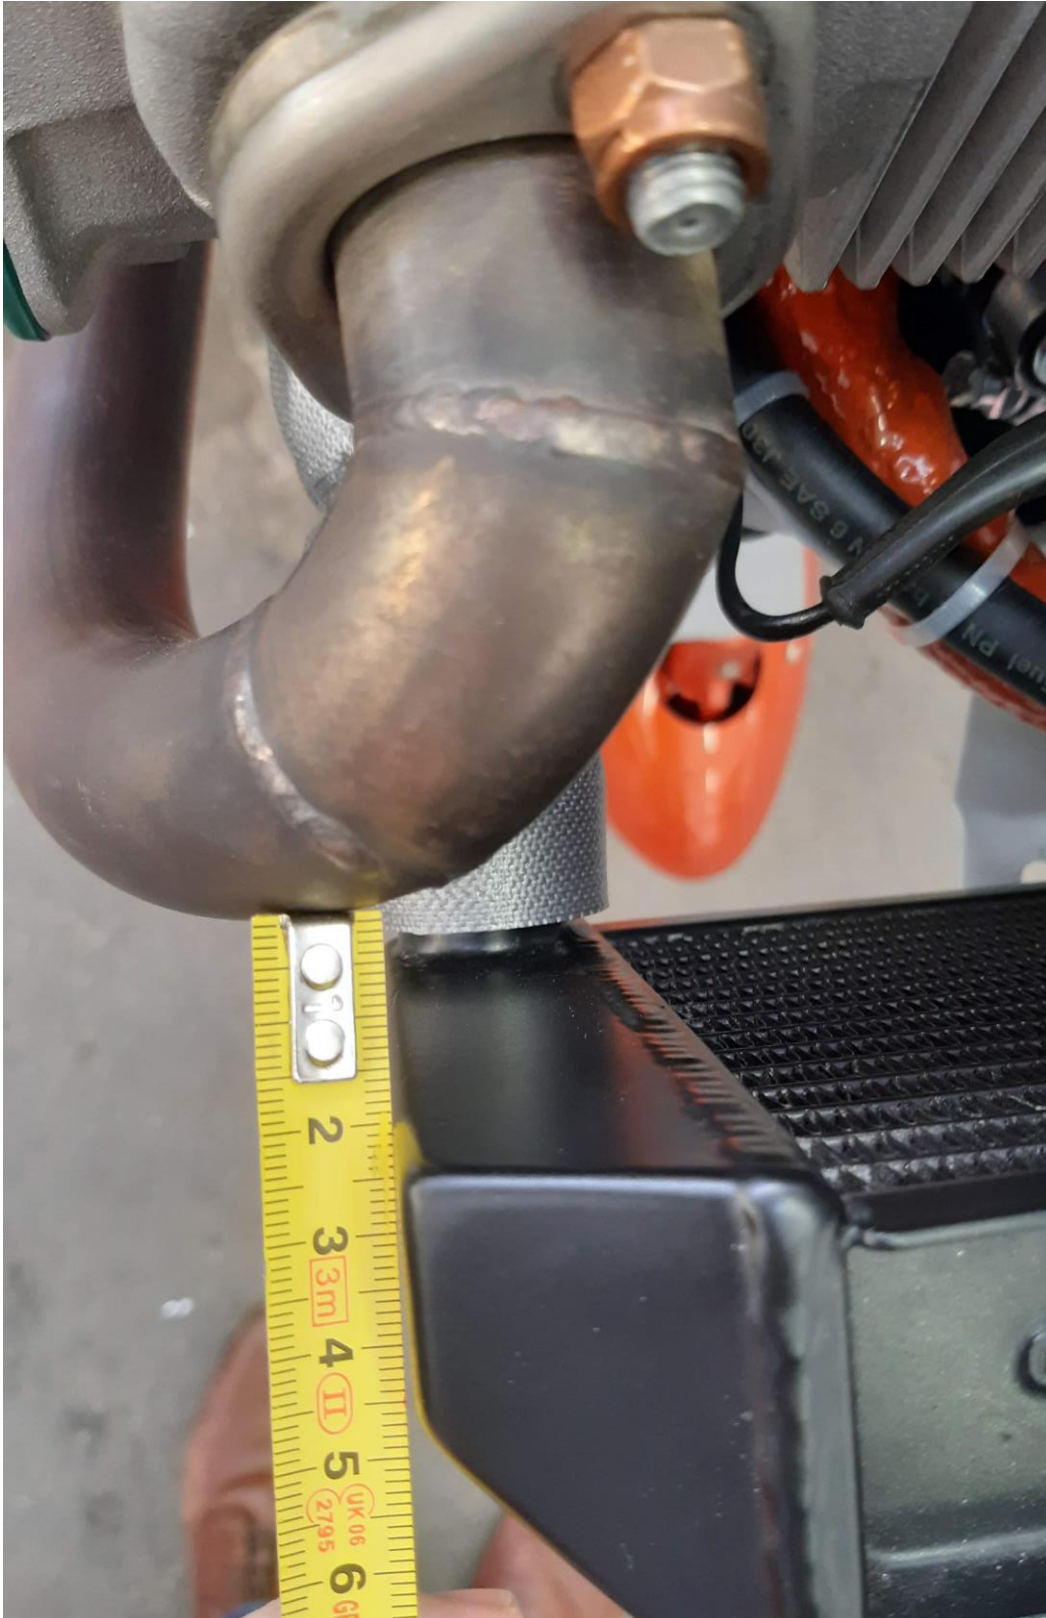
Fig. 17: Typical distance between right front exhaust and radiator

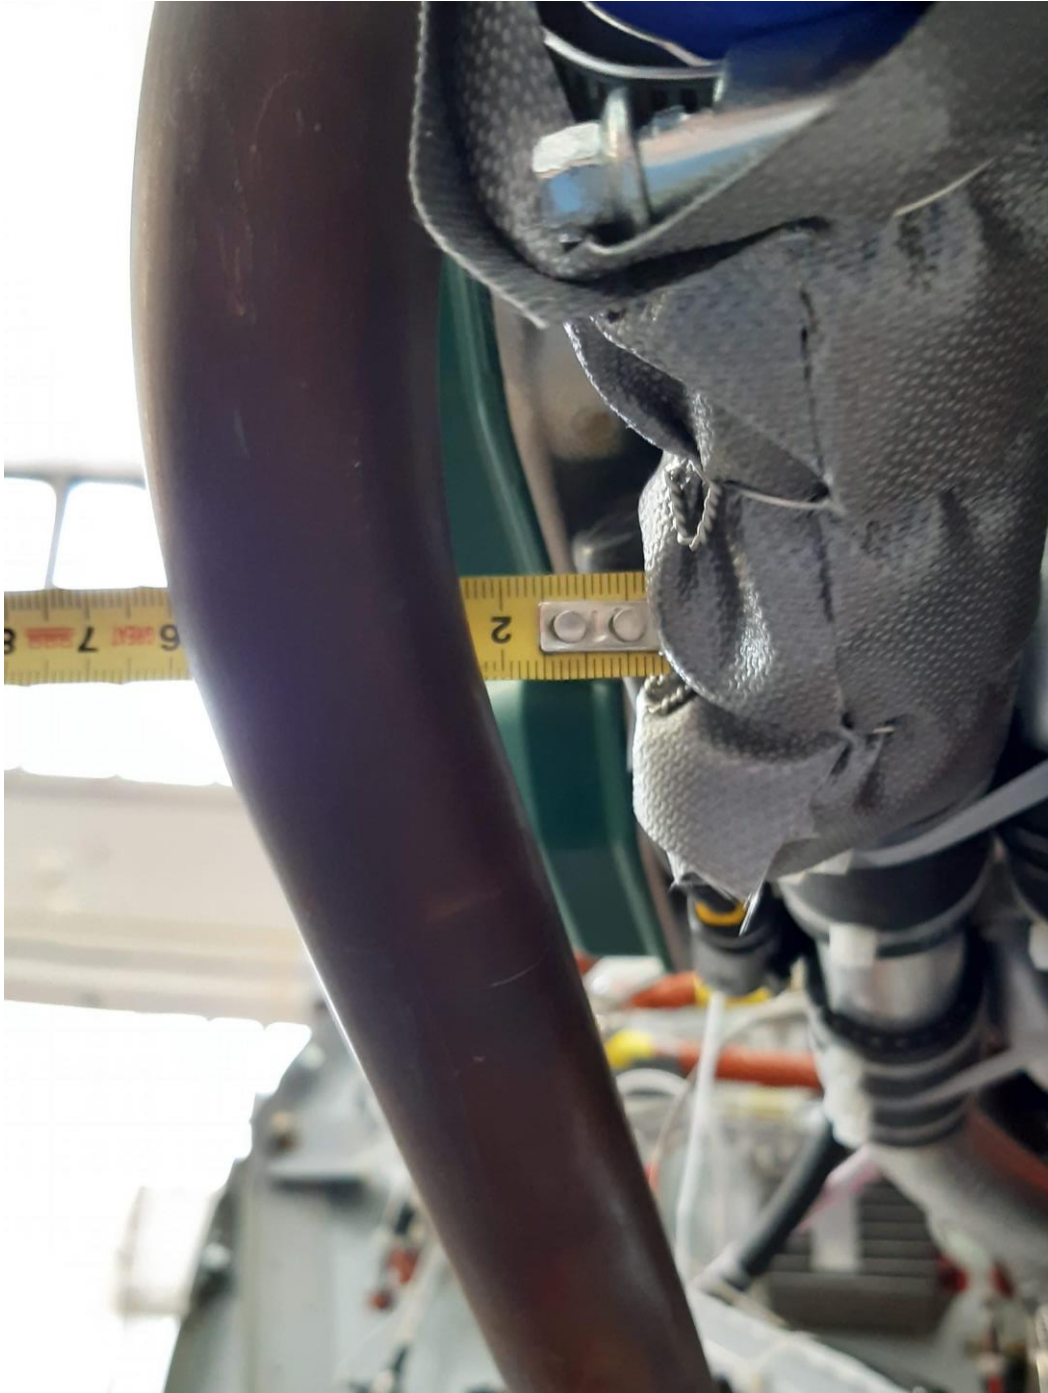
Fig. 18: Typical distance between right tube and right front exhaust

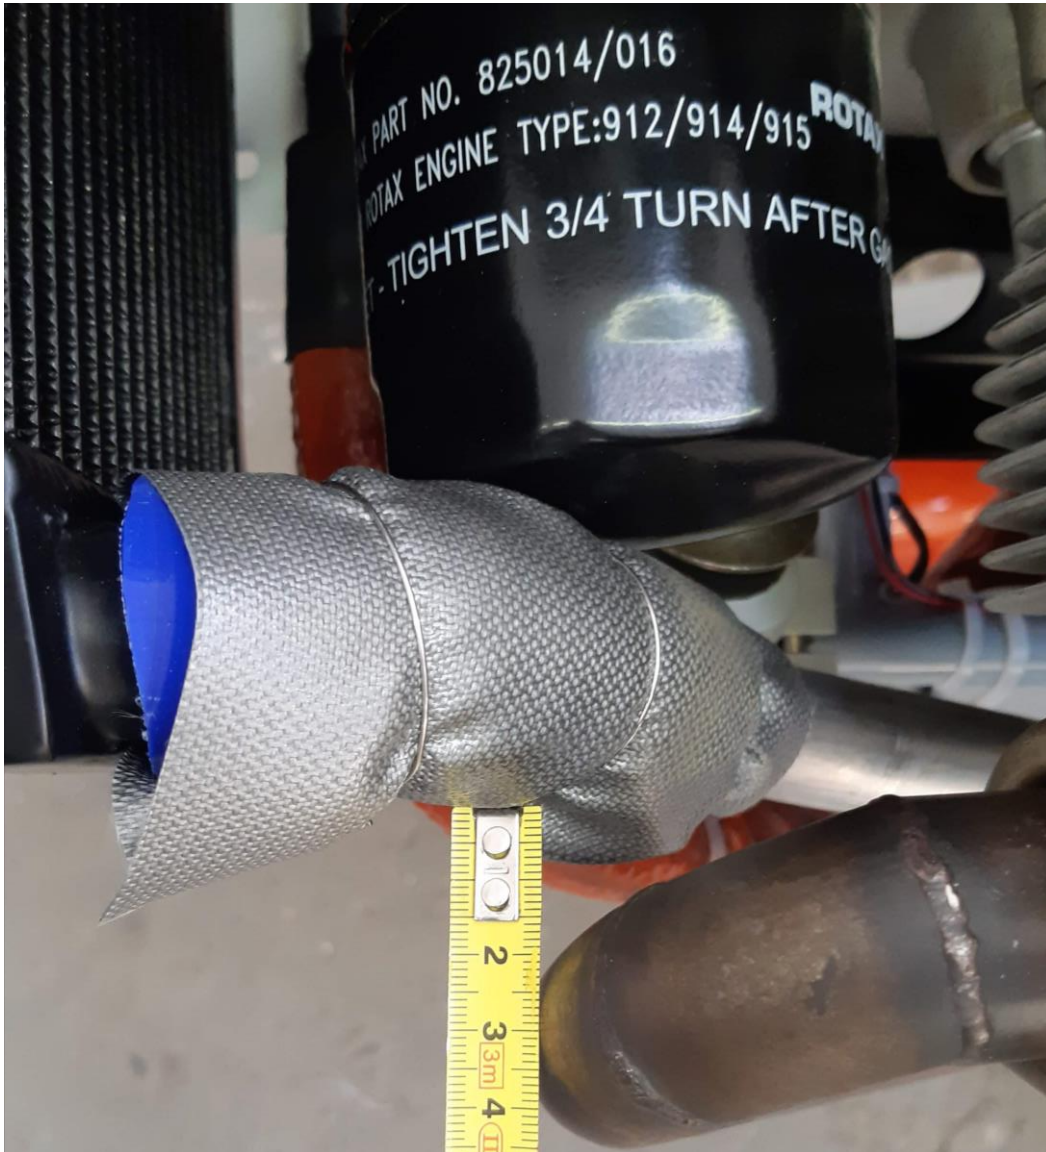
Fig. 19: Typical distance between left tube and left front exhaust.

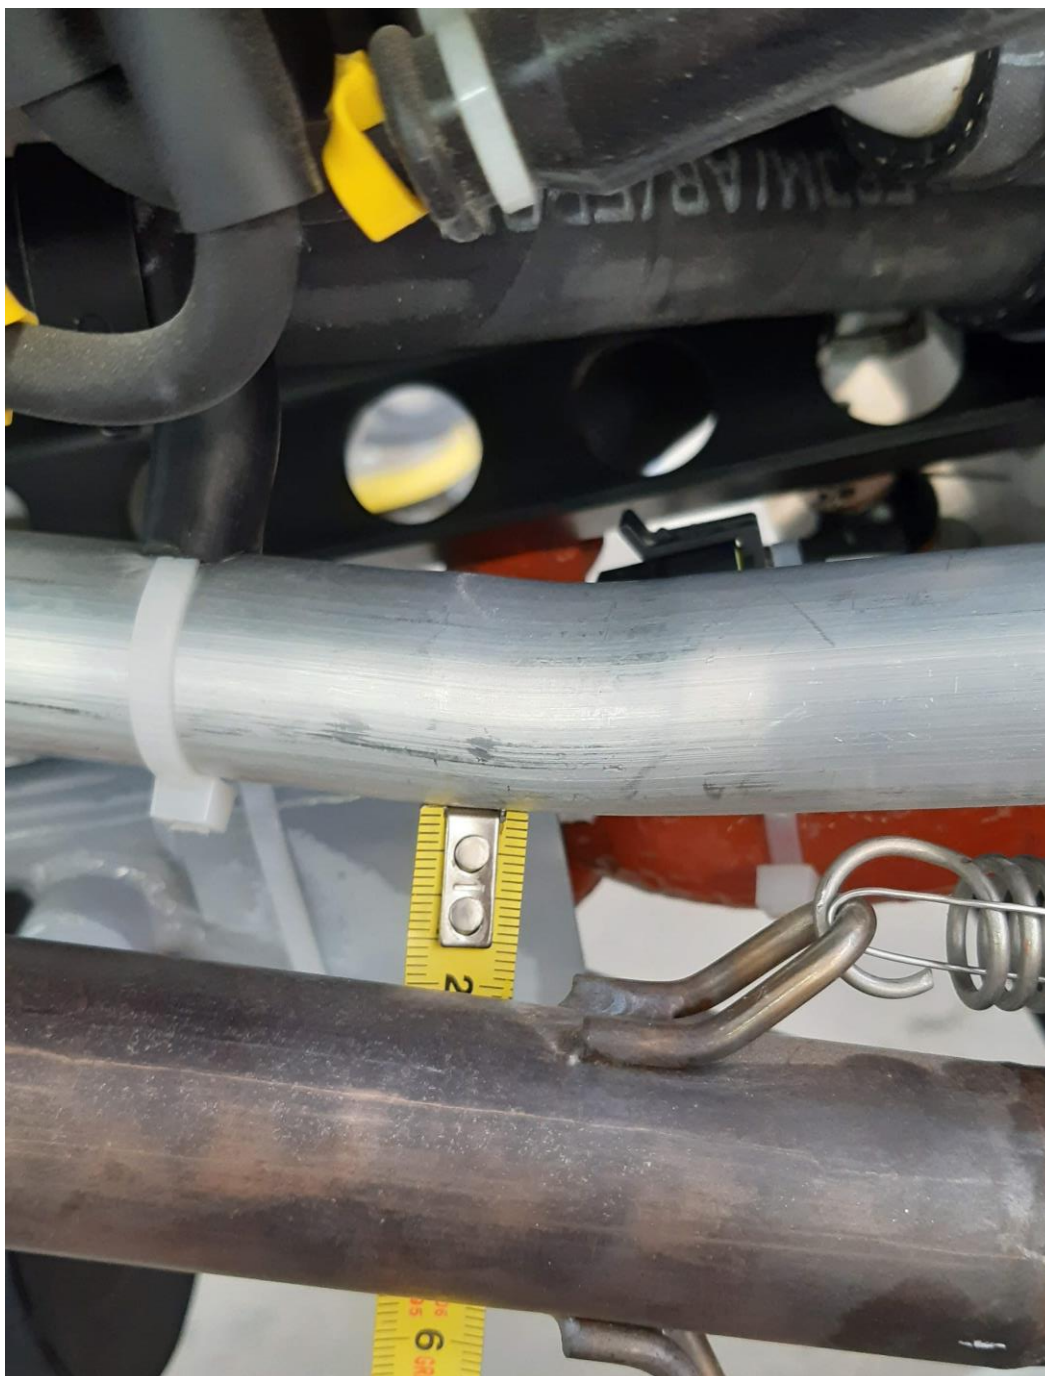
Fig. 20: Typical distance between left tube and left front exhaust.

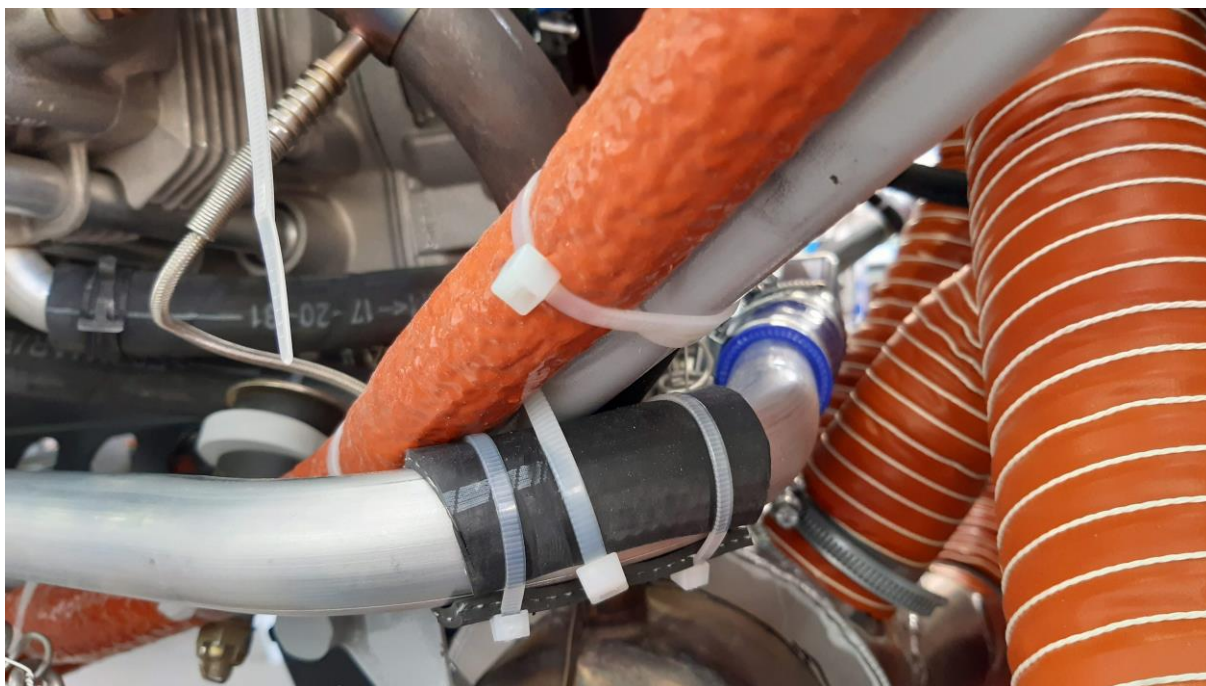
Fig. 21: Detail view of left tube and engine mount.

- 16) Prevent the tubes from moving by using zip ties (item 703 and 704) and attach the tubes to the engine. Avoid direct contact zip ties with hot metal parts using piece hose (item 702) or rest of blue hose (item 9, 10) as a shield. One wall of hose can be axially cut for easier slip on.  
Piece of hose (item 702) or rest of blue hose (item 9, 10) use as a protection for tube (item 2) against direct contact with engine mount.  
Use piece of hose (item 701) and zip tie (item 703, 704) to simple delimiter bumper.
