CRUISER
AIRCRAFT

No.: SB-SC-106

SERVICE BULLETIN

MODEL AFFECTED:	SportCruiser operating outside EASA rules
SUBJECT:	Inspection of rivets on the firewall
AIRCRAFT AFFECTED:	S/N C0692, S/N C0693, S/N C0694, S/N C0695, S/N C0696, S/N C0697 S/N C0698, S/N C0699, spare part from order No. DLV-2024-000086
COMPLIANCE:	Within the next 100 flight hours / annual inspections, whichever occurs first.

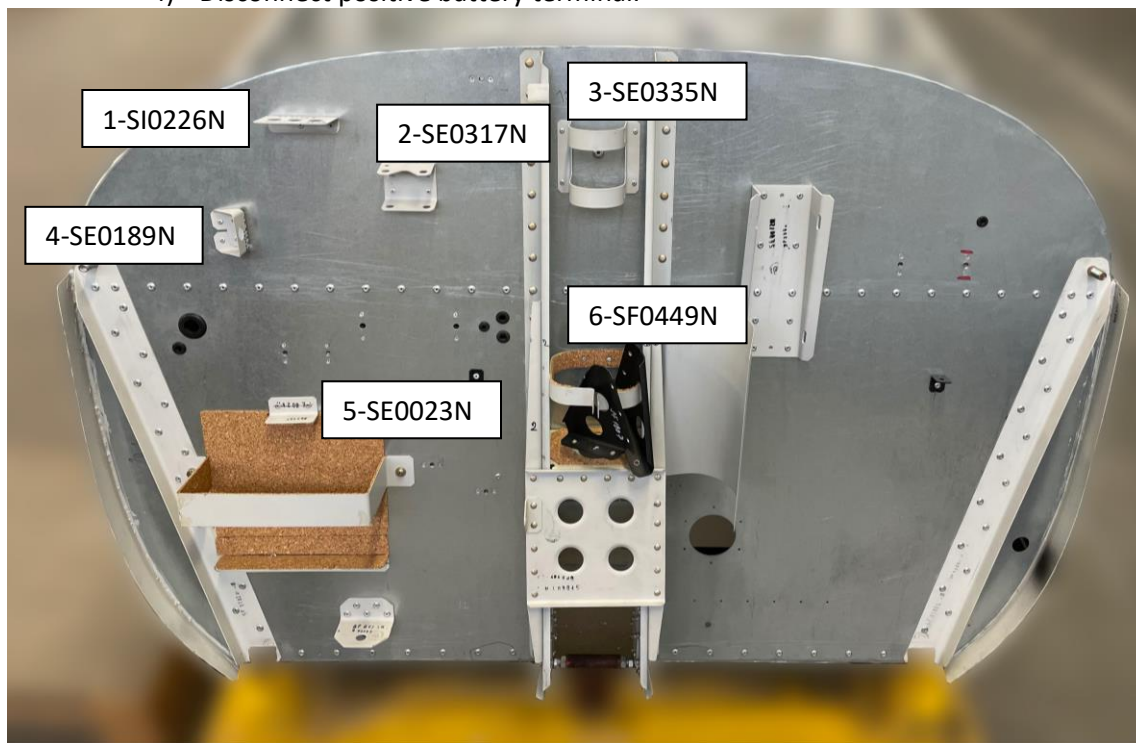
Fig. 1: Firewall

- 5) Unscrew the relay and remove flow meter on bracket SE0317N (2, Fig. 1).

- 6) Remove the tank at the SF0449N holder (6).
- 7) Inspect rivets on brackets and holders as Fig. 1 shows. Fig. 2 and Fig. 3 can be used as a guidance.

- 9) Remove equipment, hose and wires at the affected parts as needed.
- 10) Drill out non-compliance rivets and replace them with the correct rivets (001).
- 11) Restore the aircraft to airworthy condition.
- 12) Update aircraft records to reflect compliance with this Service Bulletin.
