No.: SB-SC-109

## SERVICE BULLETIN

MODEL AFFECTED:	SportCruiser / PiperSport operating outside EASA rules
SUBJECT:	Checking the bolts in front landing leg
AIRCRAFT AFFECTED:	All Sport Cruicer / DiperSport operating outside EASA rules
COMPLIANCE:	500 or more landings Basic check: Within next 5 FH and then after every 100 FH or API Detail inspection: 100 FH or API (one time action)

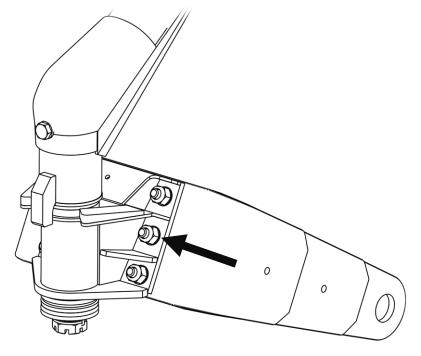
Fig. 1: Front landing leg

CAUTION: THE LOOSE SCREWS MUST NOT BE TIGHTENED BUT MUST BE REPLACED. THESE BOLTS ARE ELONGATED AND DAMAGED.

- 1) Move the aircraft to a place suitable to perform the work.
- 2) Remove the wheel fairing and front wheel from front landing leg.
- 3) Check all 6 bolts on the nose leg fork (see Fig. 1).
- 4) Bolts have to be removed and visually inspected. Check especially:
  - a) Cracks.
  - b) Threat deformation.
  - c) Bolt deformation (bend or elongation).

- 5) Replace all bolts, nuts and washers (6pcs).
- 6) Use fresh nuts and washers (item 002 and 003) for assembly. Tighten the new bolts to the prescribed torque of 8 Nm.
- 7) Fill and send Aircraft Failure Card (AFC) to <u>info@cruiseraircraft.cz</u> in case of any finding. Attach photos of damaged bolts (whole bolts, detail of damage and symbols on bolt head).
- 8) Restore the aircraft to airworthy condition.
- 9) Update aircraft records to reflect compliance with this Service Bulletin.
