CRUISER
AIRCRAFT

No.: SB-CR-071

SERVICE BULLETIN

MODEL AFFECTED:	PS-28 Cruiser / SportCruiser / PiperSport (operating under EASA rules)
SUBJECT:	Inspection and eventual adjustment of the sufficient distance between the exhaust and cooling tubes
AIRCRAFT AFFECTED:	PS-28 Cruiser / SportCruiser / PiperSport aircraft with dual circuit thermostat valve Hektik F 1104 installed
COMPLIANCE:	Apply this Service Bulletin as soon as possible, not later than before completing three flight hours as of the day of this Service Bulletin issue. Apply this service Bulletin every 100 FH or at any time when any works on exhaust or cooling tubes are performed.

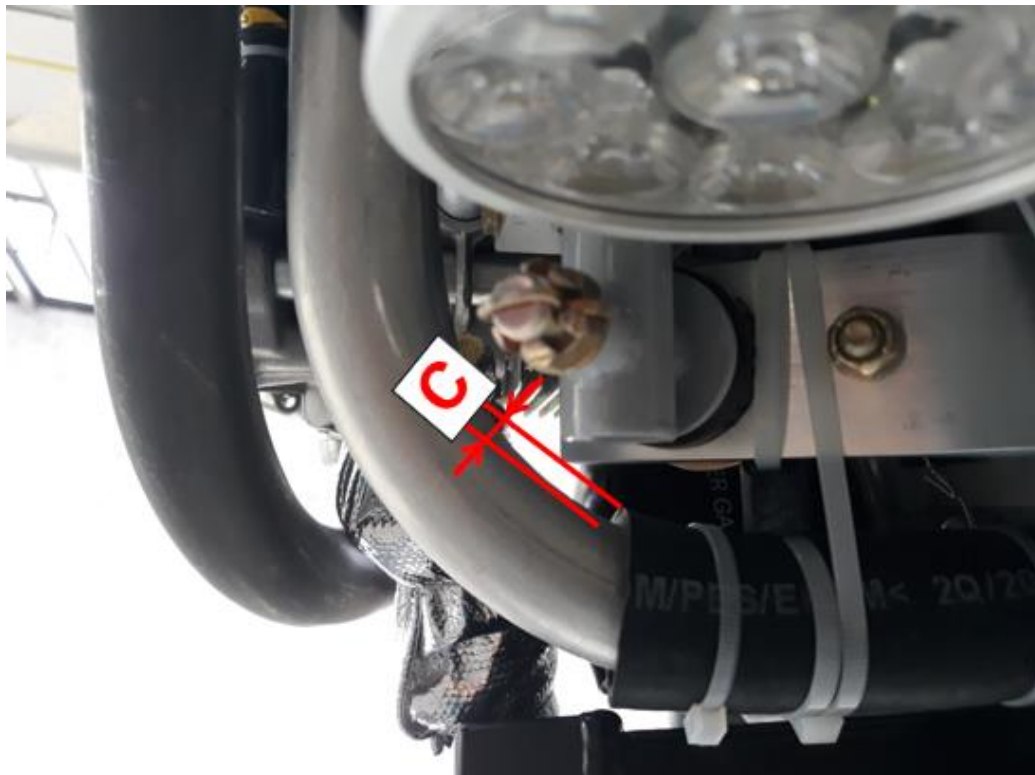
Figure 3: Distance between cooling tube and engine mount – left side – bottom view

Figure No.	Dimension	Recommended minimum distance from hot parts and other components (mm)
Figure 1: Distance between exhaust and coolant tube	A	8
Figure 2: Distance between exhaust and thermostat valve	B	8
Figure 3: Distance between cooling tube and engine mount – left side – bottom view (left side)	C	5
Figure 4: Distance between cooling tube and engine mount – right side – bottom view (right side)	D	5
Figure 5: Distance between cooling tube and alternator sensor – view from above	E	5
Figure 6: Distance between cooling tube and Spark plug – view from the right	F	2
Figure 7: Distance between cooling tube and fixing stripe free ends	G	10
Figure 8: Distance between cooler and exhaust	H	8

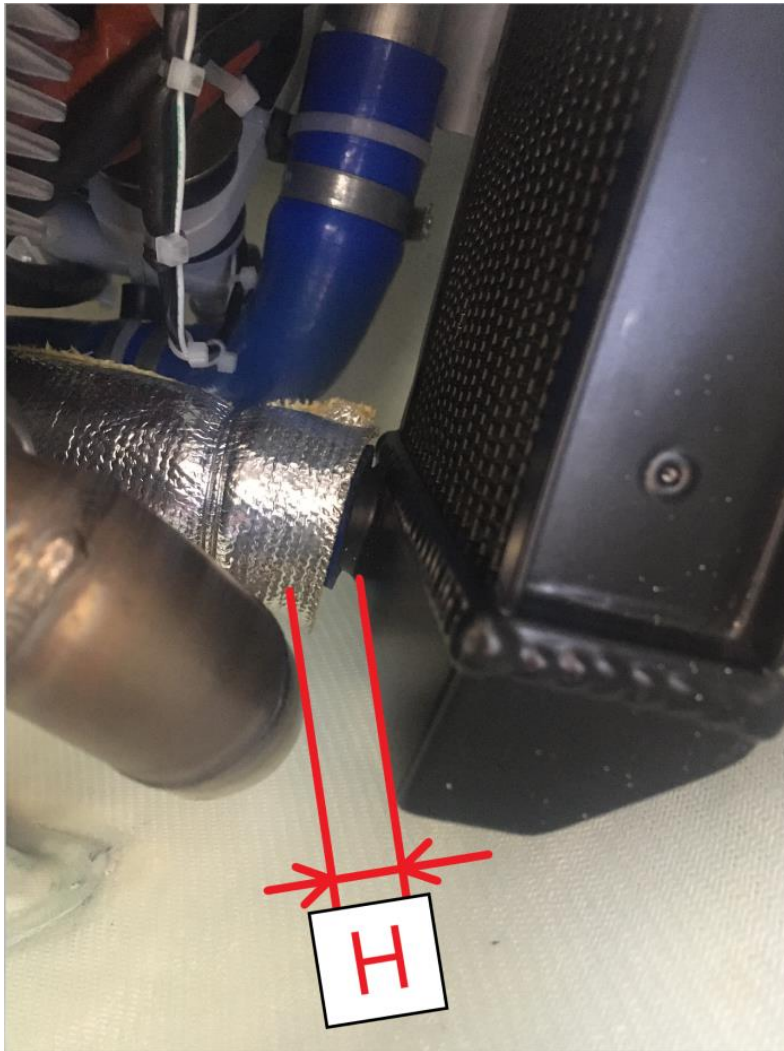
Figure 8: Distance between cooler and exhaust
