CRUISER
AIRCRAFT

SERVICE BULLETIN

No.: SB-CR-086

MODEL AFFECTED:	PS-28 Cruiser SportCruiser / PiperSport operating under EASA rules
SUBJECT:	Substitution of Kuntzleman light
AIRCRAFT AFFECTED:	All PS-28 Cruiser aircraft All SportCruiser / PiperSport operating under EASA rules
COMPLIANCE:	According to the owner's decision.

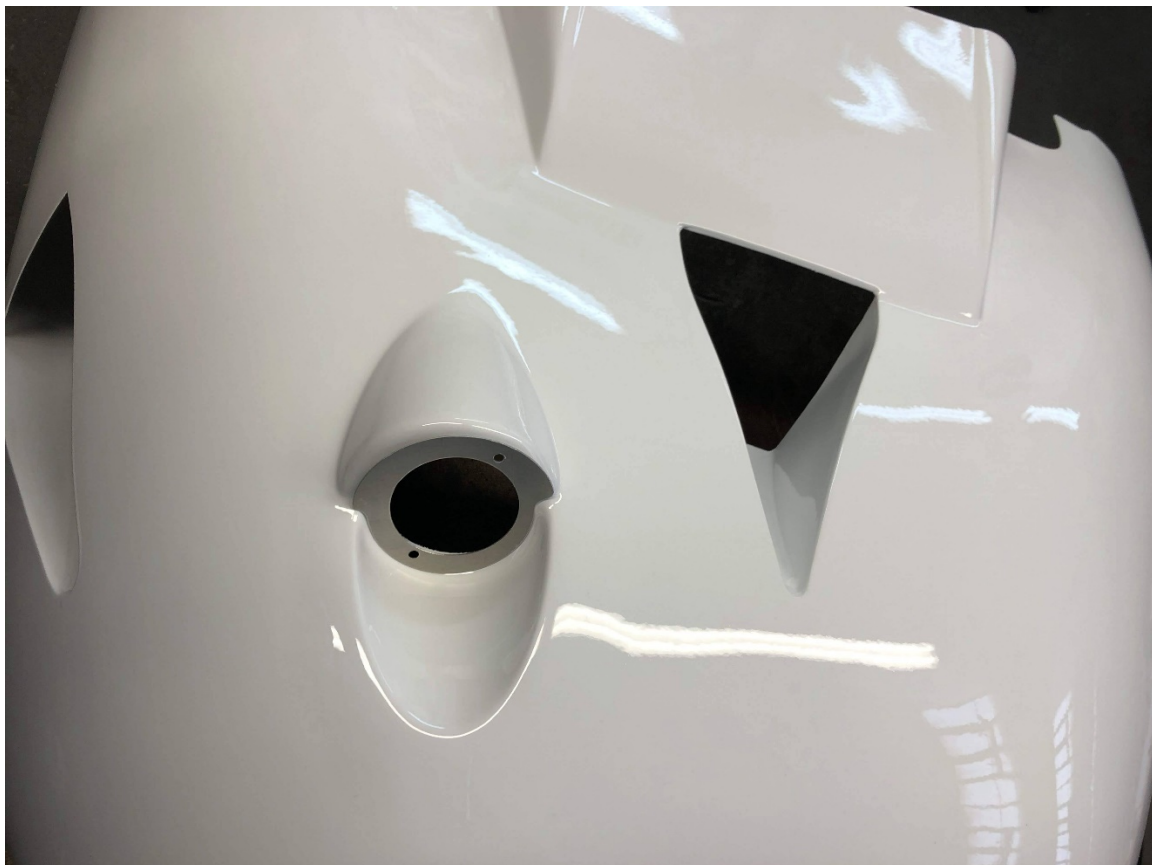
Fig. 1: Patch

1. Set the **MASTER BAT** and **LDG L** switch to OFF.
2. Remove engine cowlings, disconnect positive (+) battery terminal (see MM, Chapter 11).
3. Remove the original landing light (see MM, Chapter 11).
4. Degrease the surfaces where the adhesive will be applied.
5. Stick the patch (002) from the outside with glue (008 or 009). See Fig. 1.

6. Fill the patch with glue.
7. Drill two holes for screws throw the patch.
8. Locally repair the paint (not necessary-esthetic only).
9. The light has 5 wires, only two will be used. Red 351C (positive) and black 352C (ground), blind the other wires with a shrink tube (006). See Fig. 2. Valid scheme depends on airplane equipment.

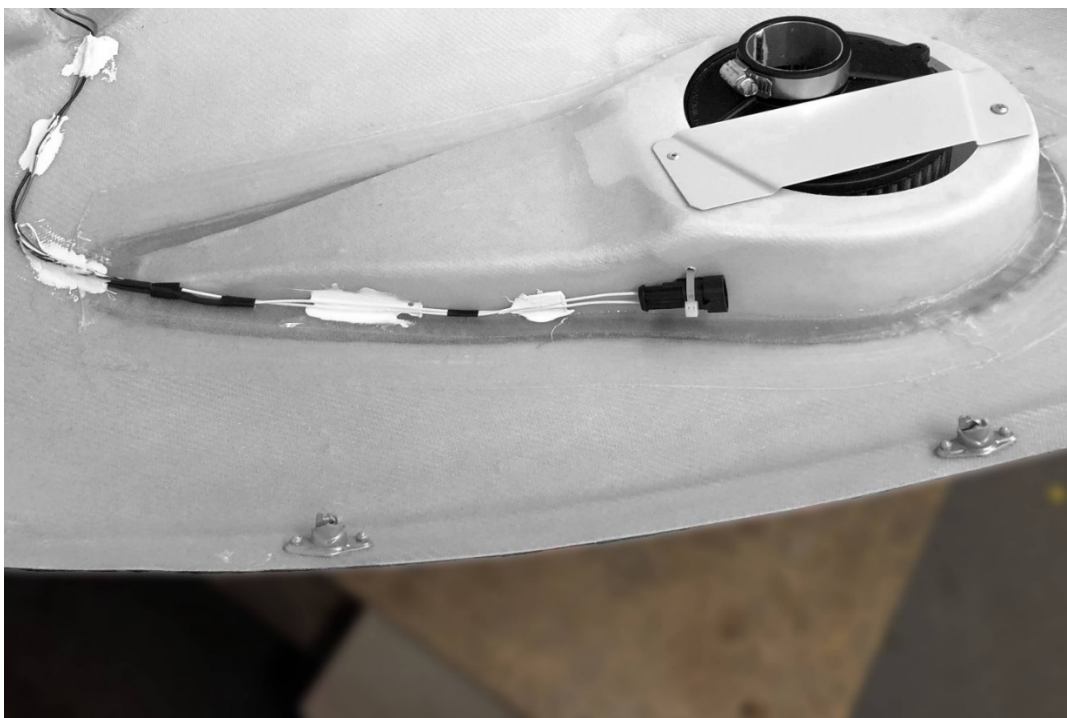
Fig. 3: Glued wires

10. Install the light (001) from the inner side and tighten the screws (003) with washers (004). Use Loctite (007) to secure the screws.
11. Extend the wires from light. So, they are above the left NACA intake.
12. Install lower engine cowling.
13. Extend the power cords over the left NACA intake.
14. Crimp the connector to power cords and wires from light.
15. Glue the wires with from light glue over the left NACA intake. See Fig. 3.

16. Let's cure the glue for 24 hours.
17. Connect the connector.
18. Connect positive (+) battery terminal (see MM, Chapter 11).
19. Install upper engine cowling.
20. Set the **MASTER BAT** and **LDG L** switch to ON and check the correct function of light (Fig. 4).
21. Complete the aircraft records to reflect compliance with this Service Bulletin.
