CRUISER
AIRCRAFT

No.: SB-SC-103

SERVICE BULLETIN

MODEL AFFECTED:	SportCruiser / PiperSport operating outside EASA rules
SUBJECT:	Accomplishment of ROTAX Bulletin SB-912-077UL / SB-912-077. Exchange of stator assy. for ROTAX 912 Aircraft Engines.
AIRCRAFT AFFECTED:	All aircrafts with 912 S and 912 ULS engines.
COMPLIANCE:	-On undelivered engines prior to delivery -Before the initial installation in an aircraft and/or spare part -Carry out this exchange of the stator on the engines listed in APPLICABILITY, according to the instructions in section 3 at the next ROTAX scheduled maintenance event, but at the latest after 1 year (from the date of the initial issue of this SB) These maintenance instructions shall be considered at any maintenance events, retrofitting, repair and overhaul.

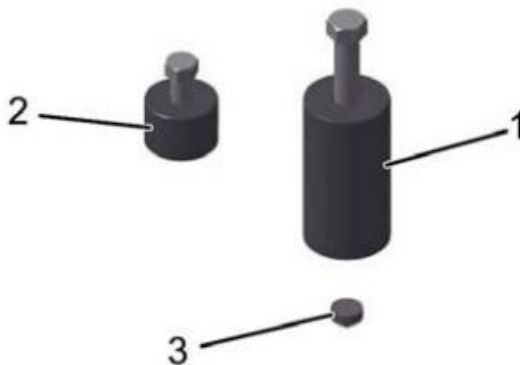
Fig. 1: Pullers

*Depending on the installation situation 2 variations of the puller assy. of different length are available. See Fig. 1.

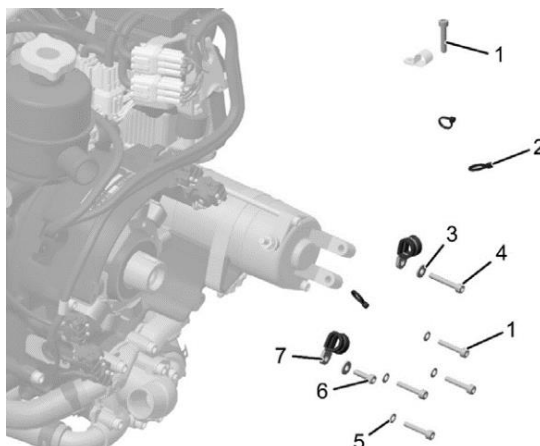
Fig. 2: Screws

- 1 part no. 240187 Allen screw M5x25
- 2 part no. 866710 Tie wrap 142x2.5 mm
- 3 part no. 945830 Lock washer A5
- 4 part no. 940882 Allen screw M5x30
- 5 part no. 945830 Lock washer A5
- 6 part no. 840514 Allen screw M5x16
- 7 part no. 851250 Cable clamp 15/M5

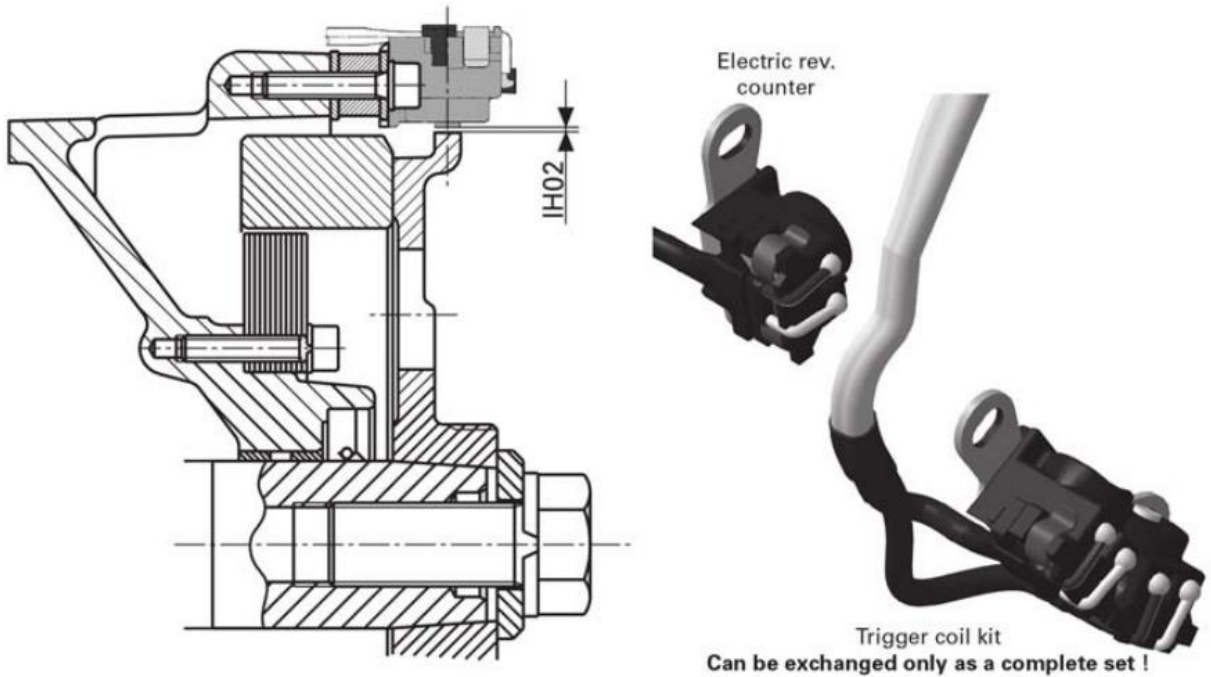
Fig. 4: Gap trigger coil.

DESCRIPTION	CODE	READING NEW		WEAR LIMIT		READINGS				
		min.	max.	100%	50%		A 1/2	A 3/4	B 1/2	B 3/4
Trigger coil gap "old type"	IH02	0.4 mm (0.016 in)	0.5 mm (0.02 in)			actual				
Trigger coil gap (with clamps)	IH02	0.3 mm (0.012 in)	0.4 mm (0.016 in)			renewed
