**SUPPLEMENT No.2 to DOC.NO. SC-AMM-1-0-00****ADDITIONAL BC425-H ALTERNATOR****1 LIST OF AIRPLANES COVERED BY THIS SUPPLEMENT**

Airplane model	Serial No.	Note
SportCruiser / PiperSport – operating outside EASA rules	-	Valid only for these airplanes the owners of which decide to install the additional BC425-H alternator

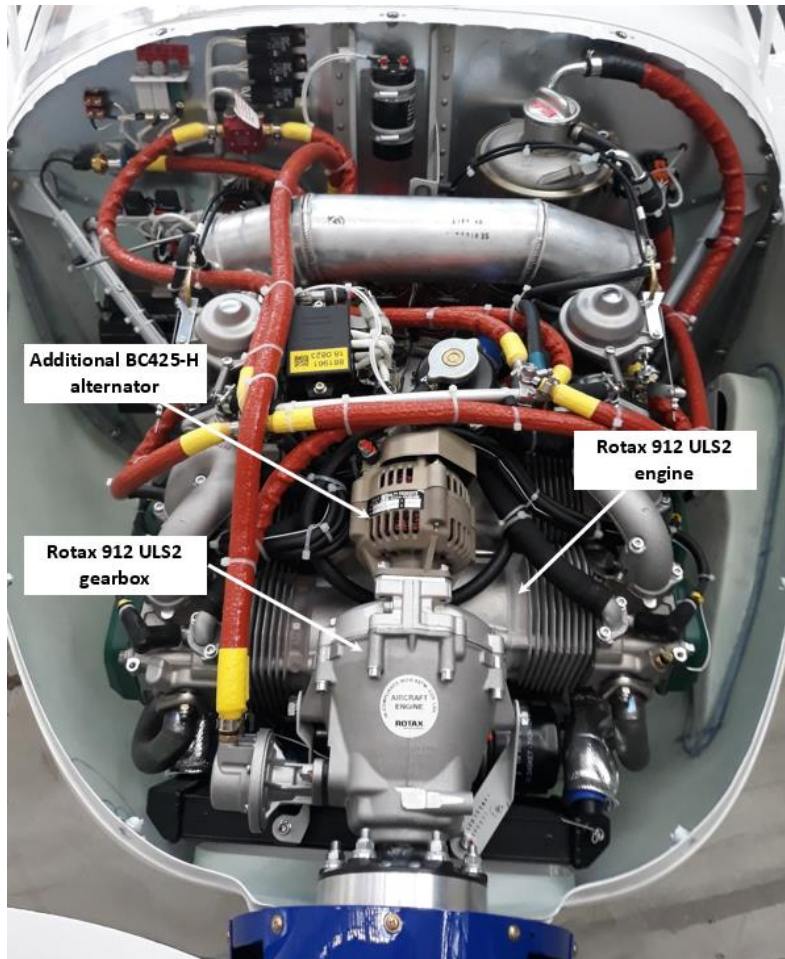
The additional BC425-H alternator is installed on the Rotax 912 engine vacuum pump accessory pad in the gearbox. Speed reduction from the Rotax crankshaft to the BC425-H alternator is 1.842, i.e. the alternator runs with 0.54 of engine RPM.

For typical installation of the additional BC425-H alternator on the Rotax 912 ULS engine, see Figures below:

Fig. 1: Installation of the additional BC425-H alternator in the Rotax 912 ULS engine

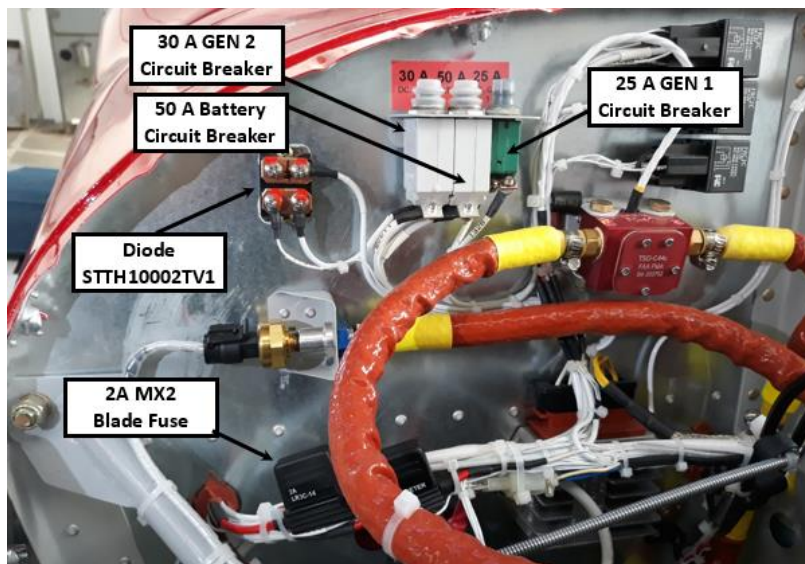
Fig. 2: Circuits protection of the additional BC425-H alternator (GEN 2)

Note: Special circuitry with a STTH10002 ultrafast recovery diode (see Figure 2) is included in the wiring to monitor additional BC425-H alternator condition. The circuitry is connected to HDX1100 MFD GEN 2 warning light output. When the additional BC425-H alternator is connected / working the GEN 2 warning light illuminates green. Whenever the additional BC425-H alternator fails, the GEN 2 warning light changes to red. Function of the main (Rotax) generator is indicated by the GEN 1 warning light output. GEN 1 and GEN 2 warning lights are located in the MFD screen on the instrument panel, see the red arrows in Figure below.

When the additional BC425-H alternator is installed, the **MASTER GEN** switch is replaced by **GEN 1** switch for the master (Rotax) generator and **GEN 2** circuit breaker for the BC425-H additional alternator. The circuits are protected by circuit breakers and fuses and are installed on the firewall, see Figure 2 above and the table below.

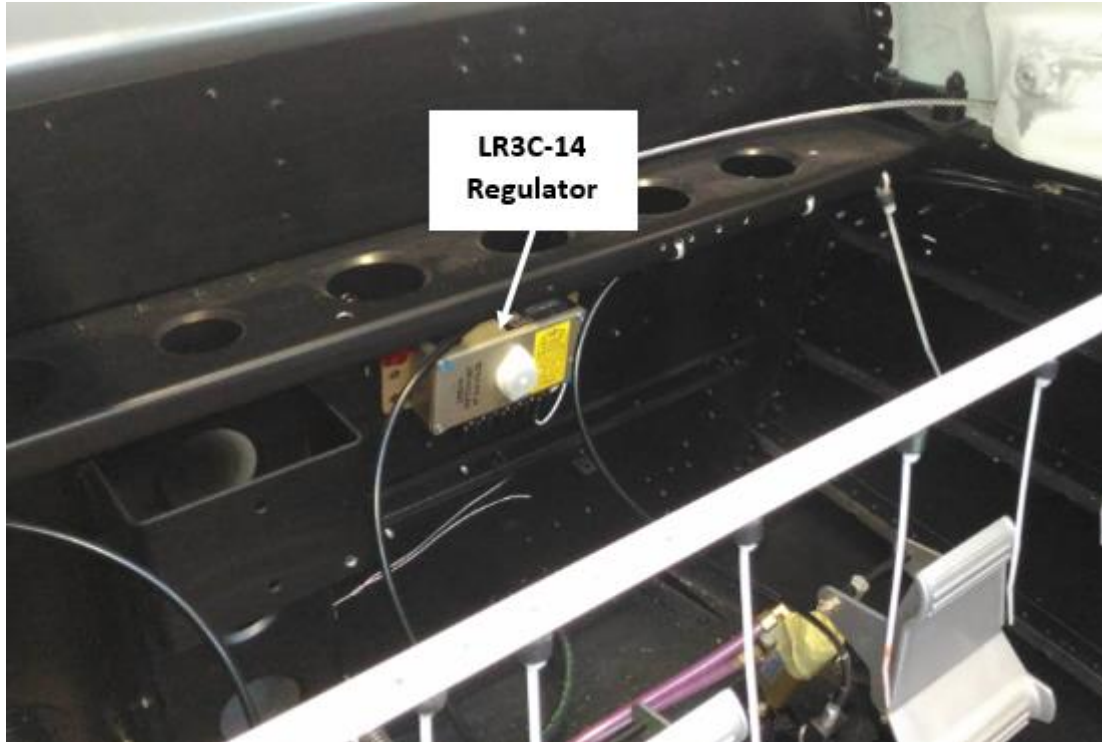
Fig. 3: LR3C-14 regulator installed on the firewall (cockpit right side)

The LR3C-14 rectifier regulator is a field adjustable unit that combines the following essential functions:

- Linear voltage regulator
- Safeguards the electrical system with solid-state “crowbar” over-voltage protection circuitry

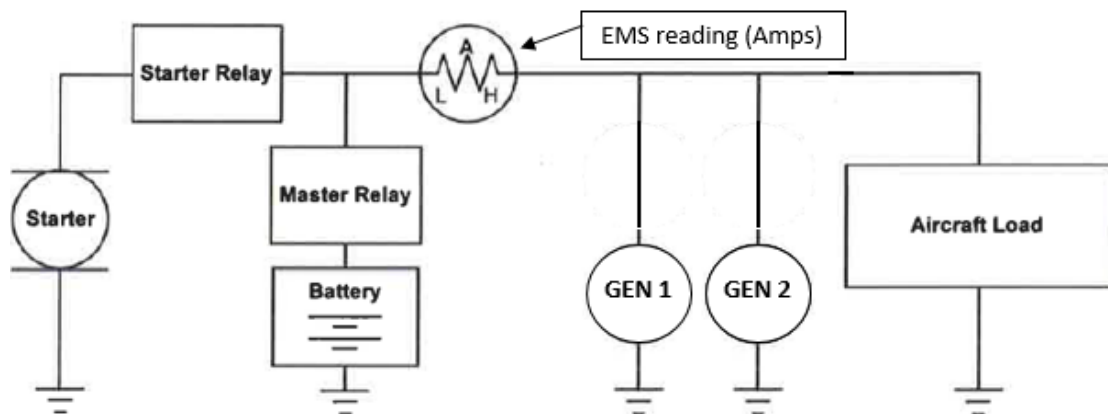
Fig. 4: General scheme of the Rotax and the additional BC425-H alternator arrangement

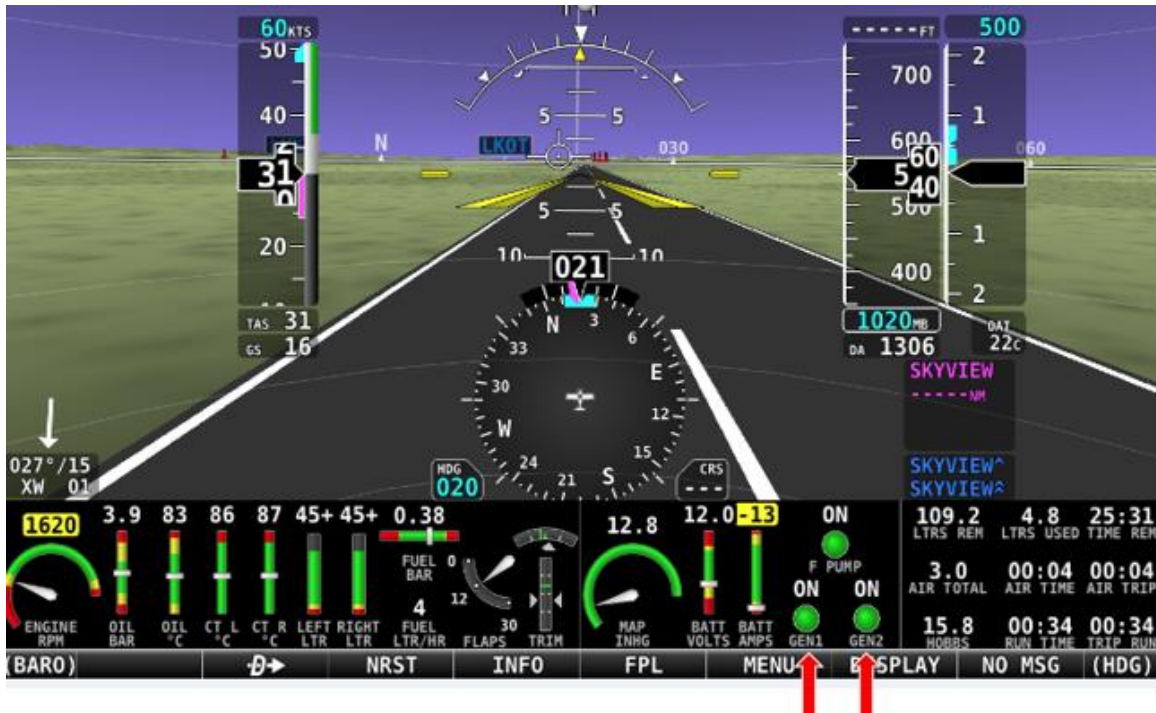
Fig. 6: Position of the GEN 1 and GEN 2 warning lights on the MFD screen

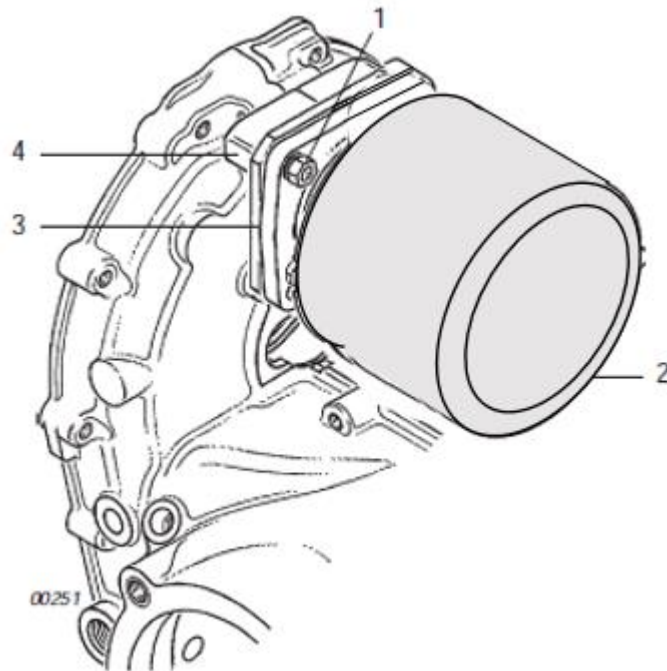
| 1 | Hex. nut | 3 | Retaining flange |
| 2 | BC425-H alternator (illustrative view) | 4 | Crankcase |

Fig. 7: Additional BC425-H alternator

See Figure 7.

- (a) Remove engine cowlings (see CR-MM-1-0-00, latest revision).
- (b) Disconnect aircraft battery (see CR-MM-1-0-00, latest revision).
- (c) Remove fixing tapes, disconnect wiring from the alternator.
- (d) Unscrew the 4 hex. nuts M6 (1) and remove the lock washers.
- (e) Remove the alternator (2) from the crankcase (4) together with the gasket and the retaining flange (3).

- (a) Fit the alternator (2), the gasket and the retaining flange (3) to the crankcase (4). Make sure the mating surfaces of the crankcase and BC425-H alternator flange are free of old gasket material and clean and dry. A thin coating of Permatex, Hylomar HPF or Loctite 518 gasket sealer on both sides of the gasket is recommended. Use aviation grade fasteners. There should be a flat washer, lock washer and full frame (not a thin frame or jamb type) nut on each mounting stud.

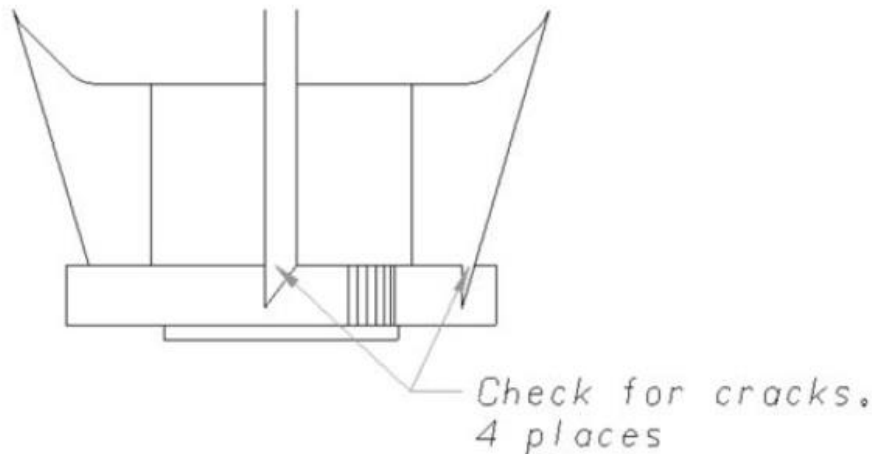
- (c) Clean the area around mounting flanges and the casting webs between the mounting flanges and the alternator housing. Check for cracks in the webs (Fig. 8). Normal tooling parting lines should not be mistaken for cracks. Any alternator identified as having cracks in any of the four webs must be returned to the factory for repair or replacement.

**Fig. 8:** Location of possible cracks

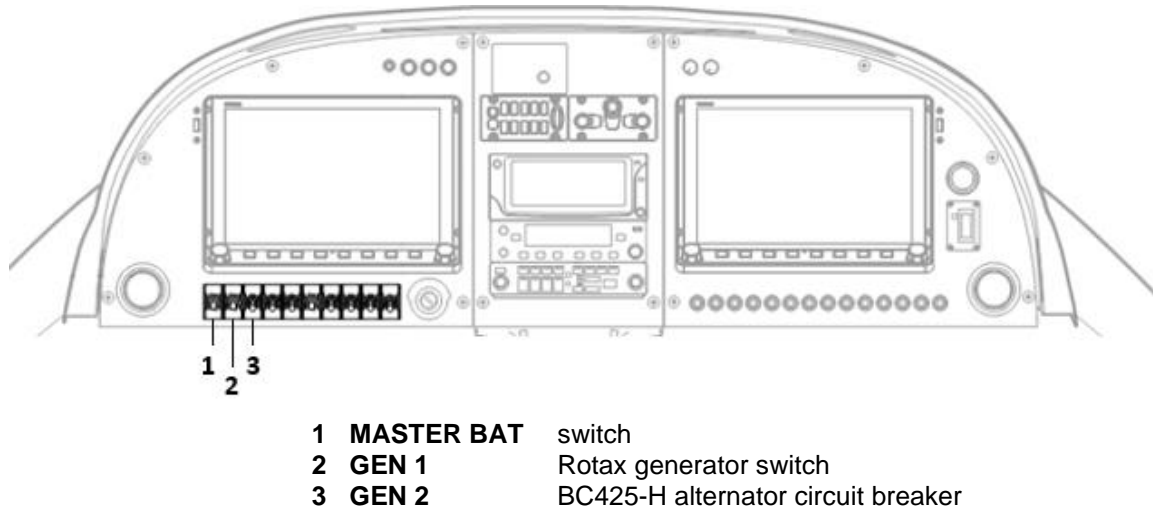
Instrument panel arrangement with the additional BC425-H alternator installed on the airplane is in Figure 12-7c.

Circuit breakers of the GEN 1 (Rotax) and GEN 2 (BC425-H) alternators are located in the bottom row of the instrument panel.

Fig. 12-7c: Instrument panel with additional BC425-H alternator and Skyview
