**SUPPLEMENT NO.1 TO DOC.NO. SC-AMM-1-0-00****INSPECTION AND / OR REPLACEMENT
OF THE VALVE PUSH-ROD-ASSY., ROCKER ARM
FOR ROTAX® ENGINE TYPE 912 S2 and 912 ULS2****1 LIST OF AIRPLANES COVERED BY THIS SUPPLLEMENT**

The ROTAX Company issued Service Bulletin SB-912-070UL, SB-912-070 R1 for ROTAX® Engine Type 912 (Series) with requirement to inspect and / or replace the valve push-rod-assy., rocker arm left/right. Power loss and engine RPM drop have been reported on Rotax 912 engines in service. It has been determined that, due to a quality control deficiency in the manufacturing process of certain push-rod assemblies, manufactured between 01 May 2016 and 2 October 2017 inclusive, partial wear on the rocker arm ball socket may occur, which may lead to malfunction of the valve train.

The Supplement No.1 contains instructions for corrective action requested for Rotax engines type 912 S2 and 912 ULS2, which are installed in the PS-28 Cruiser airplane.

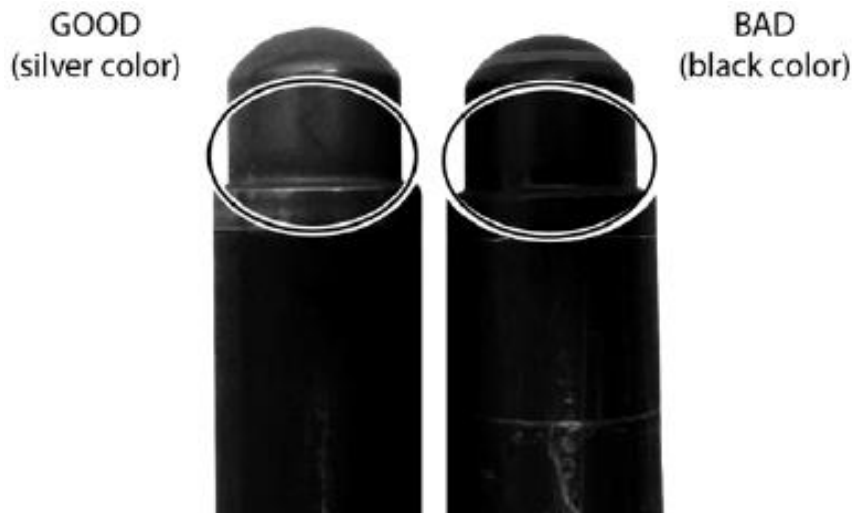
Fig.1 – Visual inspection

Perform visual inspection of all push-rod ball sockets on all cylinder.
Check for colour. See Fig.1.

Color	Evaluation
Silver surface	Valve push-rod is OK. No further action required for this valve push-rod.
Black surface	Valve push-rod is NOT OK. See section. 10.9.6) Replacement of affected parts...

Comparison of spare parts:

10.9.6 Replacement of affected parts on affected cylinder positions (only in case visual inspection is NOT passed OK)
