## SERVICE BULLETIN

MODEL AFFECTED:	SportCruiser / PiperSport operating outside EASA rules	
SUBJECT:	Replacement of the original SG0030L/P main landing gear legs by the reinforced SG0160L/P variant	
AIRCRAFT AFFECTED:	All SportCruiser / PiperSport	
COMPLIANCE:	Apply this Service Bulletin, when replacement of the original SG0030L/P main landing gear legs is required

This Service Bulletin includes instructions for replacement of the original SG0030L/P main landing gear legs by the reinforced SG0160L/P variant.

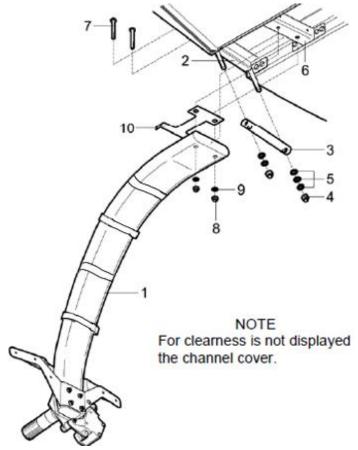
Fig. 1: Main landing gear leg

- 1 Main landing gear leg
- 2 Main gear attachment
- 3 Tube
- 4 Locknut
- 5 Washer

- 6 Chamber
- 7 Bolt
- 8 Locknut
- 9 Washer
- 10 Spacer

Securing bolts (2) and (7): Use only as many washers (9, Fig. 1) so that when the locknut (4, 8) is tightened, the bolt thread should protrude throughout the locknut not less than 1,5 pitches beyond the top of the nut or plastic insert (see SAE ARP1515 or other aviation standards).

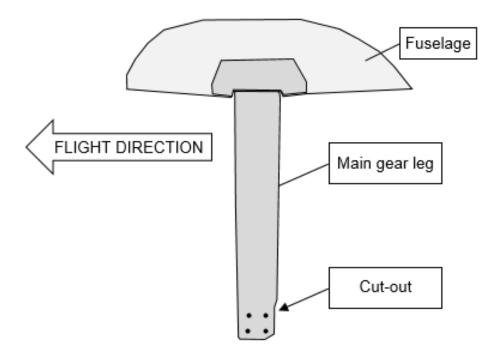
Fig. 2: Main gear leg installation (illustrative sketch)

- 3) Install the reinforced main landing gear legs, see the SC-AMM-1-0-00, Chapter 8, latest revision.
- 4) Be careful of correct position according to the flight direction. The leg has to be installed so that the cut out on the leg bottom part must be on the rear side, see Fig. 2 above.
- 5) When the leg is inserted/pushed into the final position, drill two holes Ø 8 mm for bolts (7, Fig. 1) in the main landing gear attachment (2) and spacer (10).
- 6) Install the wheels assembly, see the SC-AMM-1-0-00, Chapter 8, latest revision.

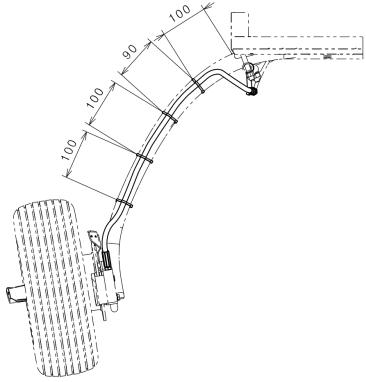
Fig. 3: Main gear leg zip tie position

- 9) Adjust the brake hose as shown (Fig. 3).
- 10) Secure the position of the zip ties with glue (013/014).
